## TEXAS NEW CONSTRUCTION

1234 Main Street  
Socorro TX 79927

# PROPERTY INSPECTION REPORT FORM

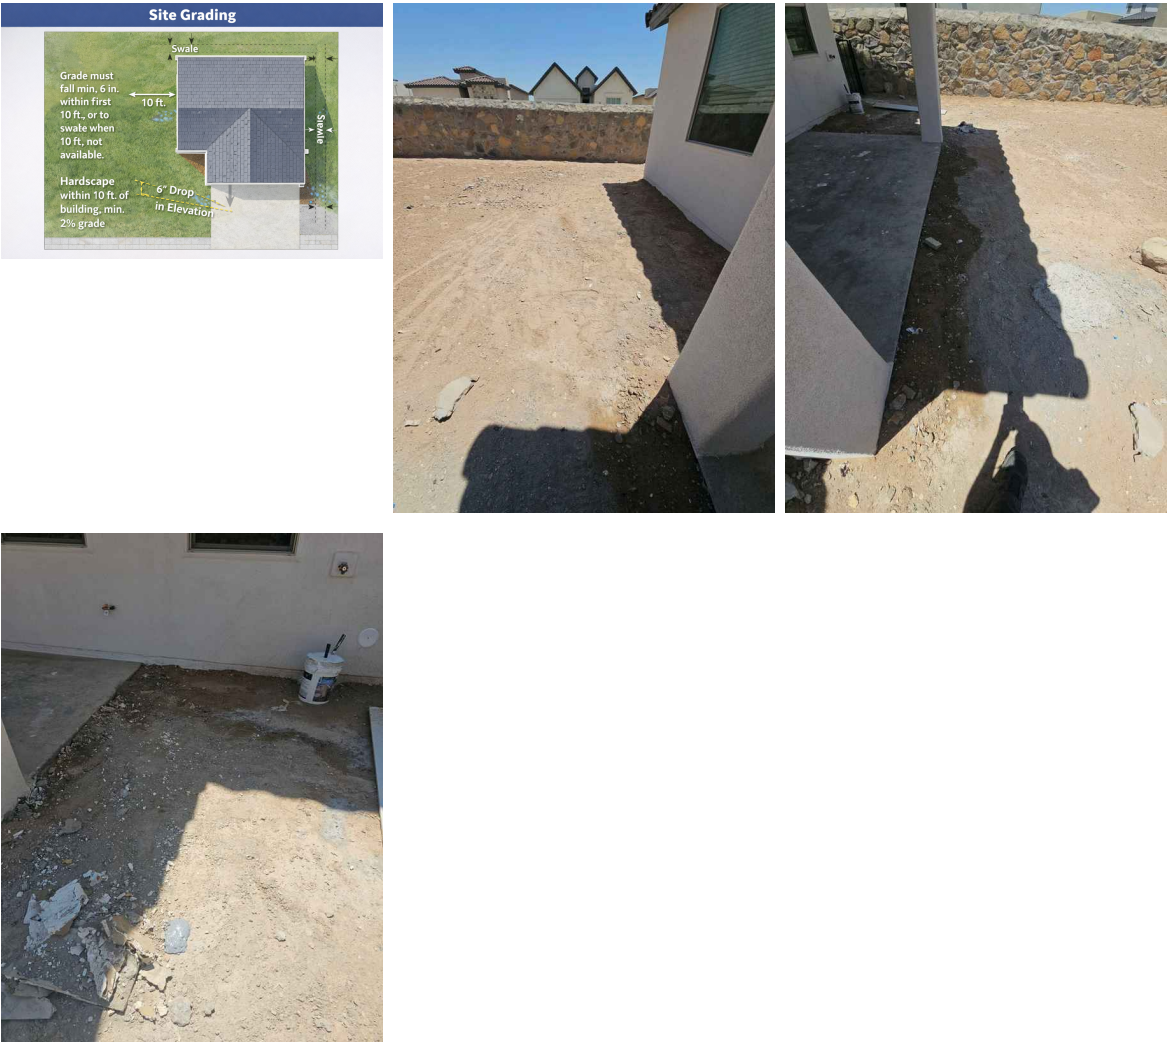
The exterior grading was relatively flat in the referenced area(s). The soil is recommended to slope away from the structure, with a 6 inch drop in elevation, in the first 10 feet away (5% grade). Evaluation of the grading in this area with repairs made as needed to allow for proper drainage and rainwater runoff is recommended by a grading contractor or other qualified person.

Recommendation: Contact your builder.

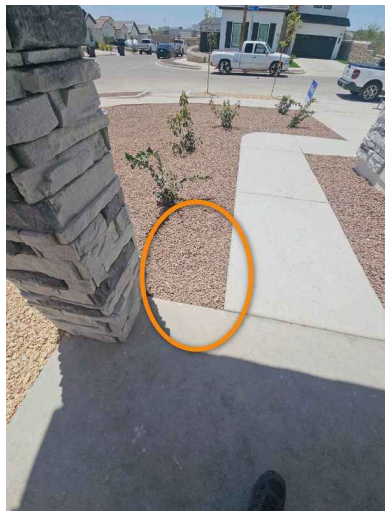
Low area(s) were present along the foundation. Low areas can allow water to pound near the foundation. Filling these low areas as needed with soil to achieve a proper slope away from the foundation is recommended to be performed by a qualified person.

Recommendation: Contact your builder.

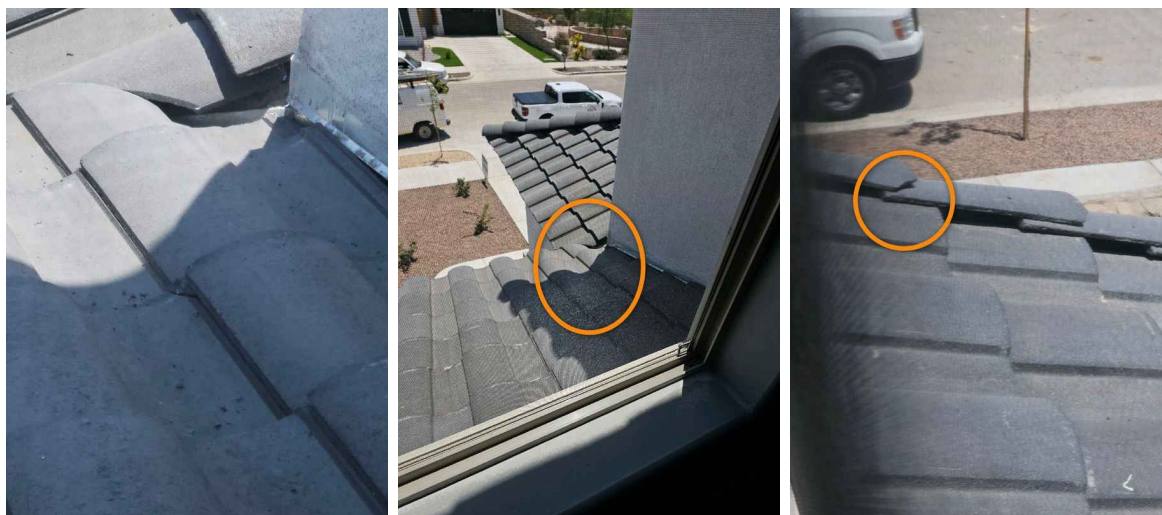
Chipped roofing tiles were observed during the roof inspection. Damaged tiles can allow water infiltration and compromise the roof's protective barrier. A roofing professional should evaluate the extent of the damage and determine whether individual tiles can be repaired or if roof sections require replacement.

Recommendation: Contact a qualified professional.

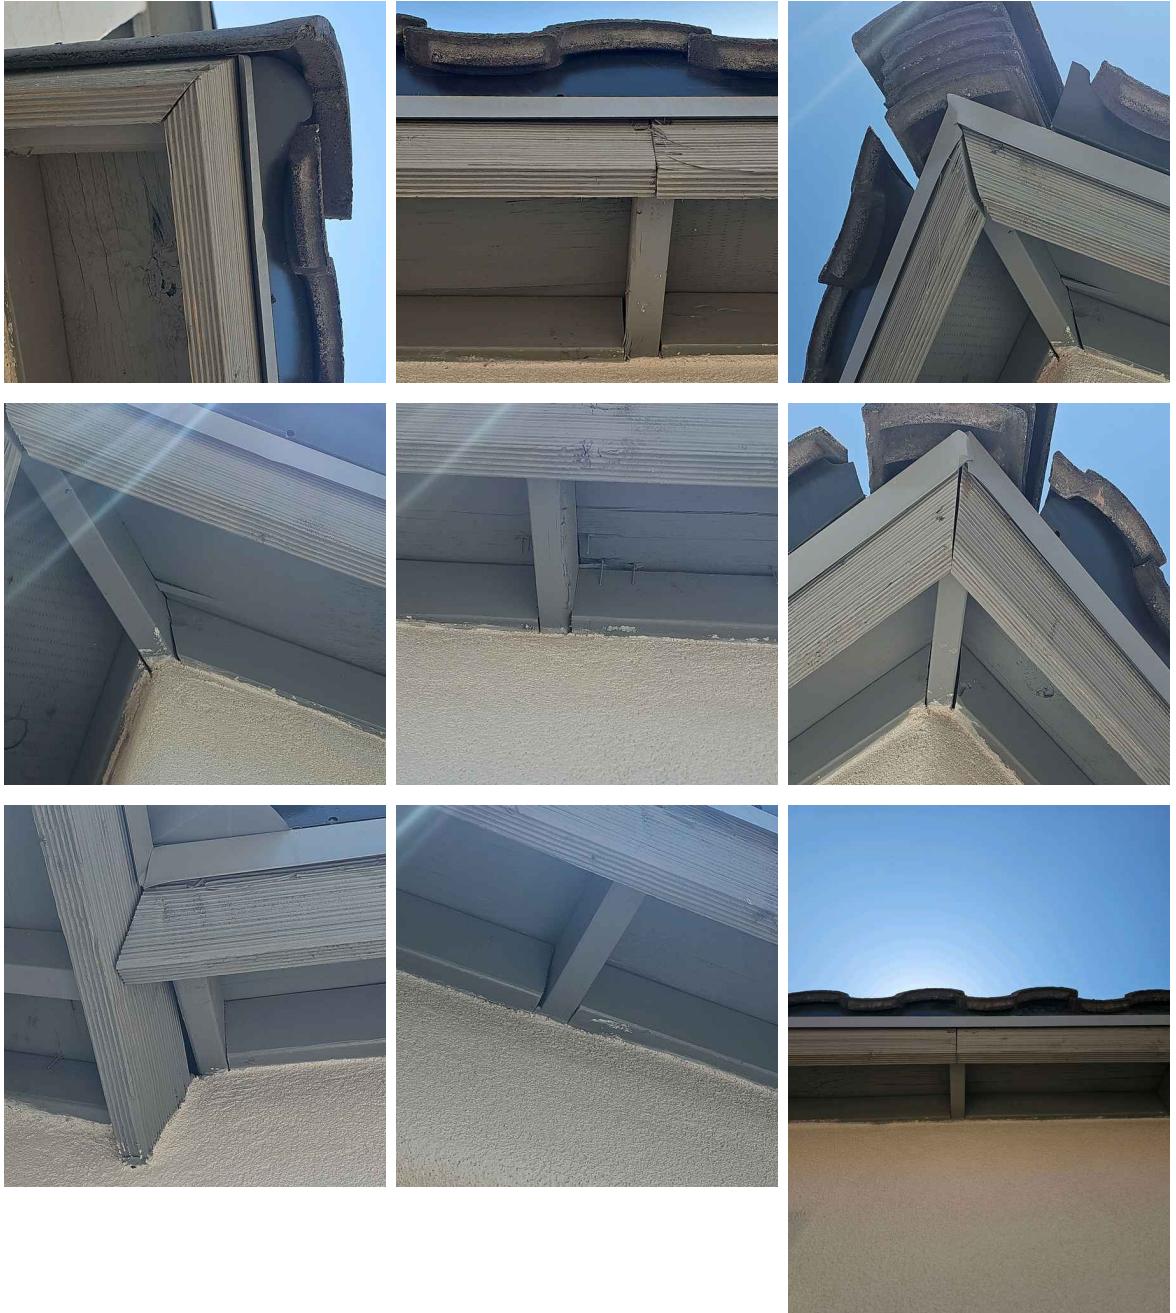
Gap at soffit/fascia/trim intersection(s). This can allow for moisture entry, where, over time can deteriorate the surrounding materials. Recommend a qualified professional evaluate the soffit/fascia/trim intersections for gaps and repairing and/or sealing all areas to prevent any further deterioration.

Recommendation: Contact your builder.

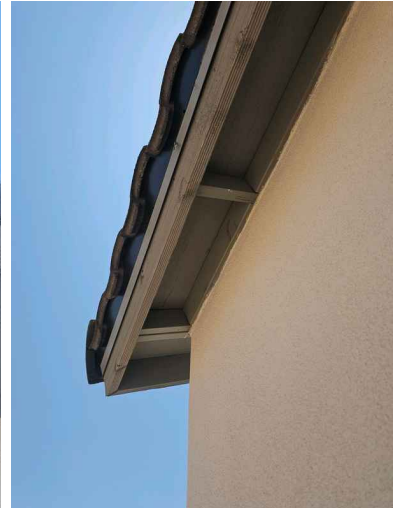
Areas of fascia/soffit were observed missing paint. Recommend builder paints areas to prevent premature deterioration of fascia.

Recommendation: Contact your builder.

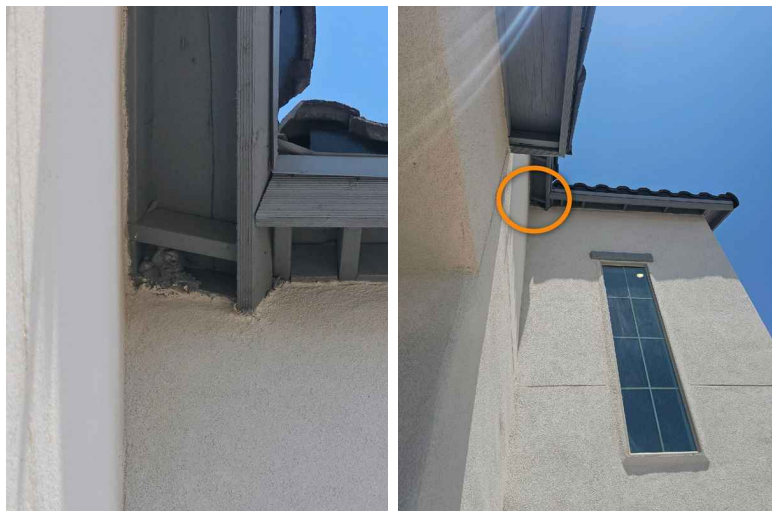
Front

#### 4: Foam Protruding From Wall at Eave

Recommendation: Contact your builder.

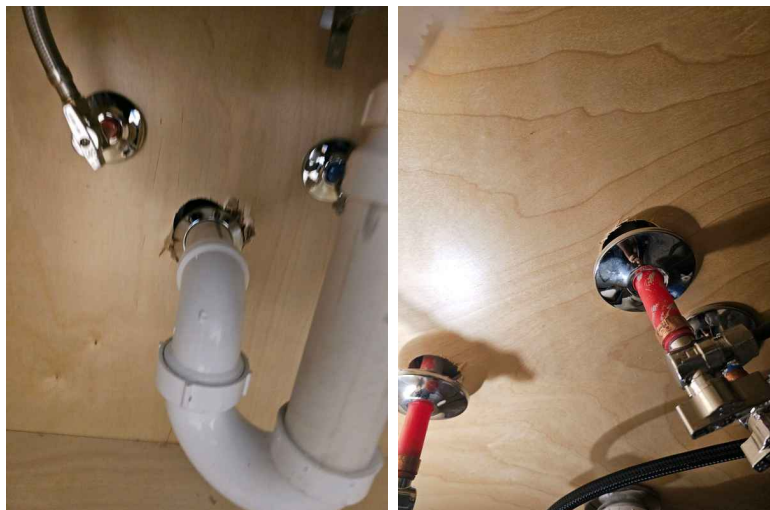
Multiple

**5: Gap at Plumbing**

Recommendation: Contact your builder.

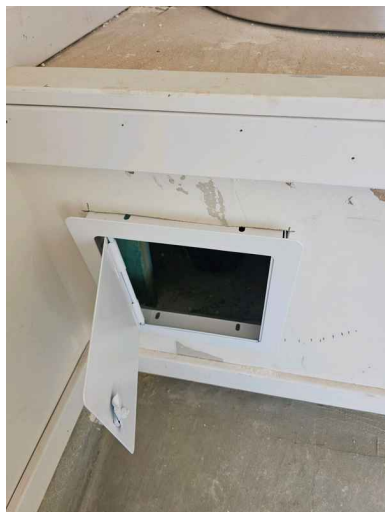
Garage

## 7: Water Shut Off Cover Not Secured

Recommendation: Contact your builder.

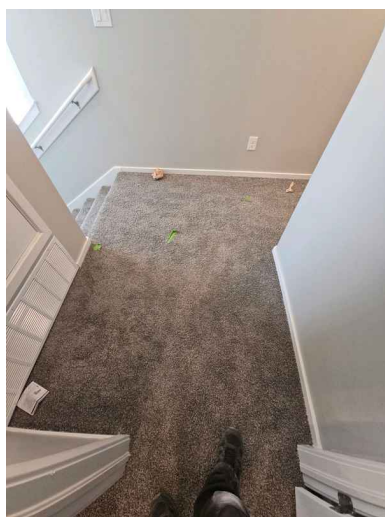
2nd Floor

## 2: Floor(s): Popping/Creaking

Recommendation: Contact your builder.

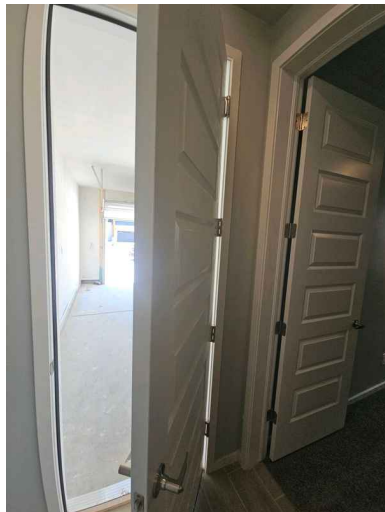
**8: Entry Door Not Self-Closing**

The entry door is equipped with a closer mechanism but is not self-closing properly. This means the door does not automatically close and latch after being opened, which can compromise security and energy efficiency. Have a door repair contractor inspect and adjust or replace the closer to restore proper operation.

Recommendation: Contact your builder.

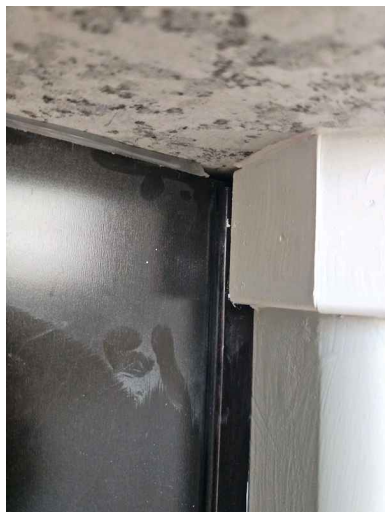
Kitchen Island

### 4: Sealant Gap at Cabinet-to-Countertop Junction

Recommendation: Contact your builder.

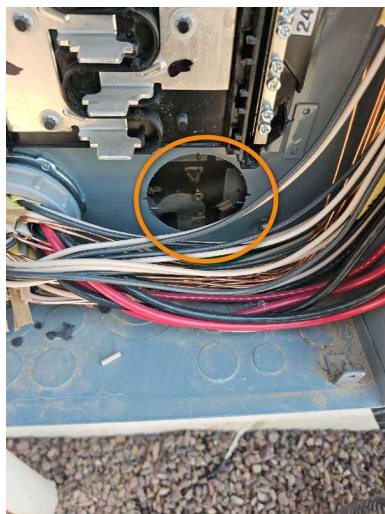
Main Panel

**2: Panel Knockout Missing**

Recommendation: Contact your builder.

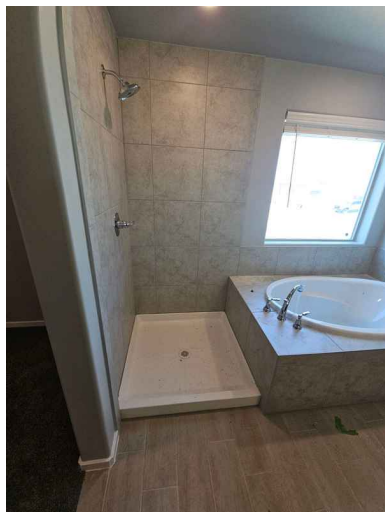
Master

### 4: Shower Doors Not Installed

Recommendation: Contact your builder.

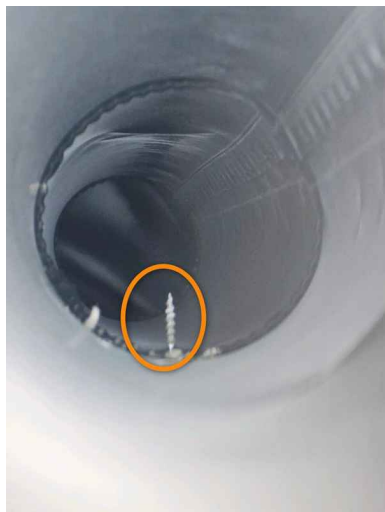
**1: Screw Protruding Into Dryer Vent****Dryer Vent**

A screw is protruding more than 1/8 inch into the dryer exhaust vent. This obstruction can restrict airflow and reduce dryer efficiency, potentially causing lint buildup and creating a fire hazard. A qualified professional should remove or replace the screw and verify proper vent clearance.

Recommendation: Contact your builder.
