## HOME INSPECTION REPORT

1234 Main Street  
Socorro TX 79927

# PROPERTY INSPECTION REPORT FORM

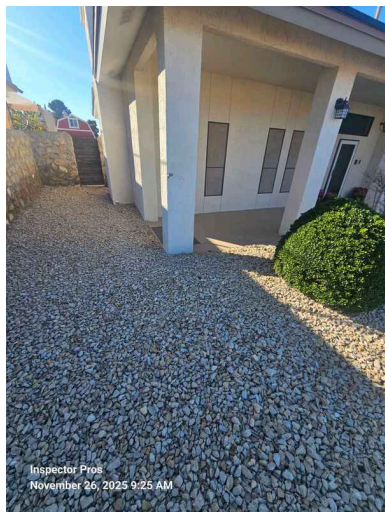
*Grading and Drainage Performance:* Improper Grading, Flat Grading, Negative Grading (slopes towards structure)

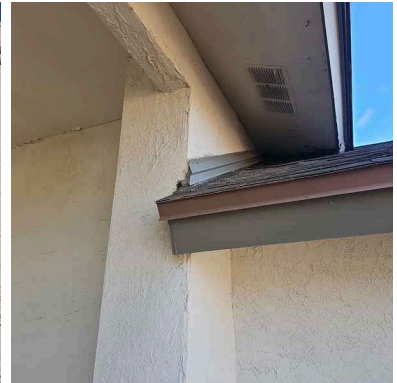
**Implication:** Without proper kickout flashing, water can flow behind the exterior cladding, potentially causing damage to fascia, trim, and wall assemblies over time.

Recommendation: Contact a qualified roofing professional.

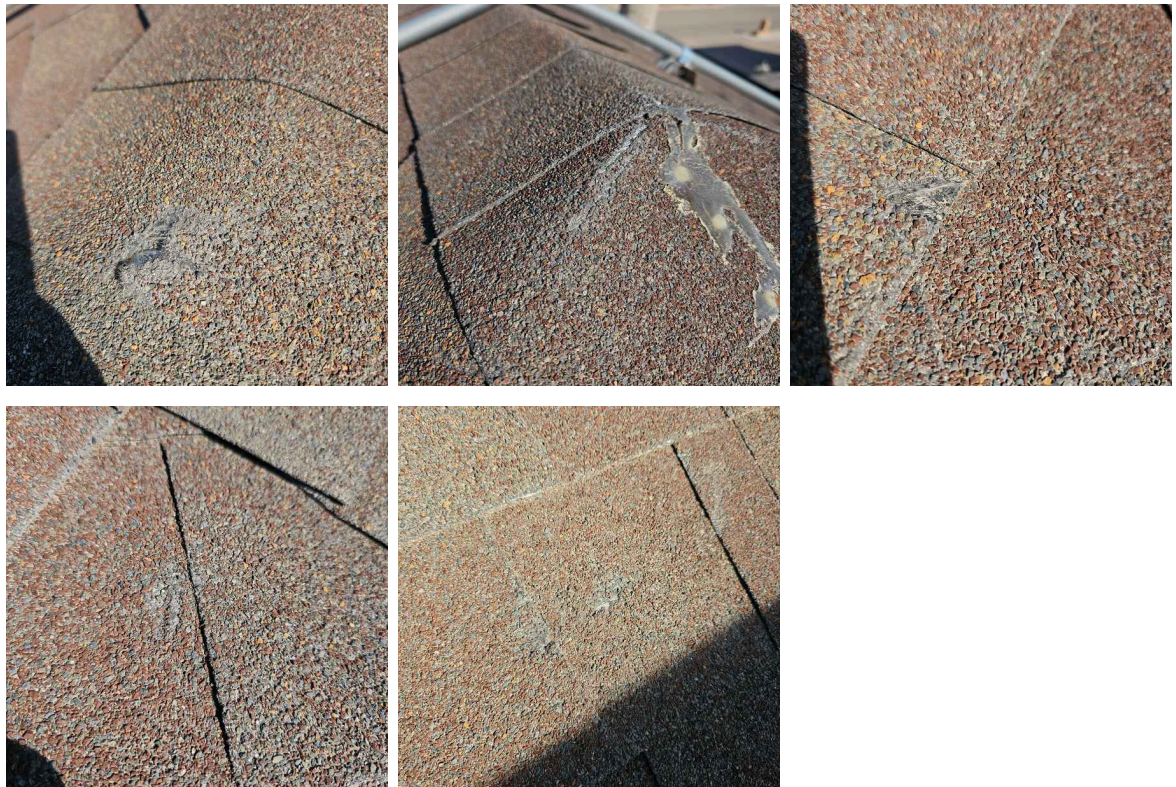
Damaged shingles can reduce the roof's ability to shed water properly, potentially allowing moisture intrusion and contributing to premature roof deterioration if not addressed.

Recommendation: Contact a qualified professional.

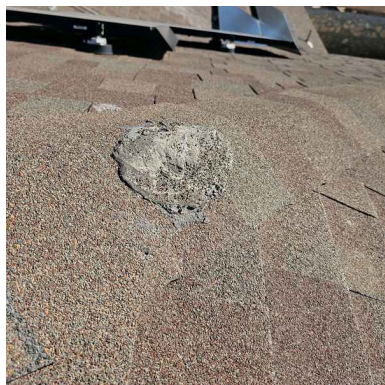
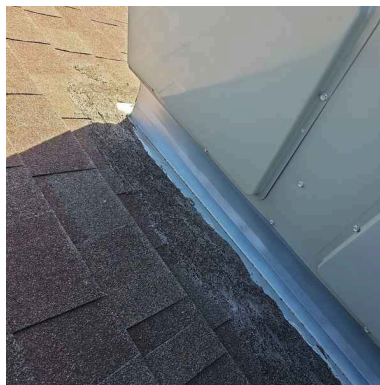
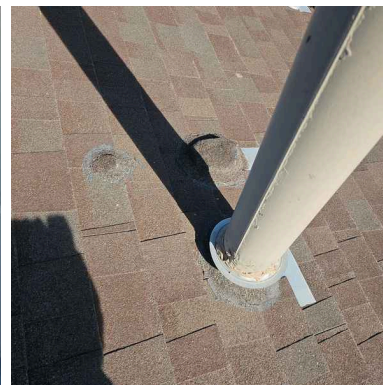
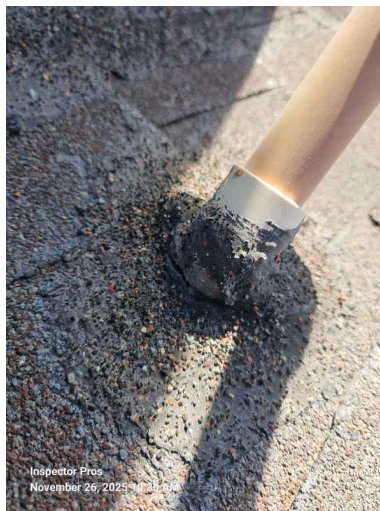
Areas lacking granules and showing cracked tar are more susceptible to UV damage, accelerated deterioration, and moisture intrusion, which can reduce the service life of the roof covering.

Recommendation: Contact a qualified professional.

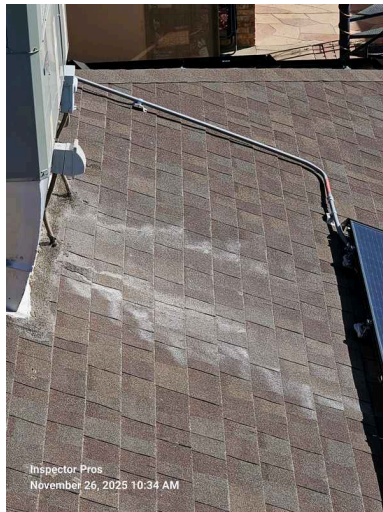
Staining from evaporative cooler discharge can accelerate shingle wear and may indicate prolonged moisture exposure in those areas.

Recommendation: Contact a qualified professional.

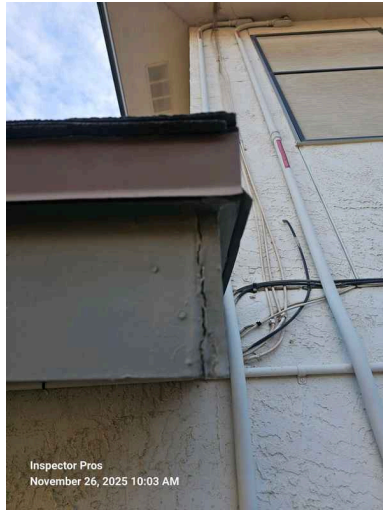
**Implication:** These gaps can allow moisture to be absorbed between the materials, potentially leading to deterioration, rot, or separation of the surrounding components over time.

Recommendation: Contact a qualified roofing professional.

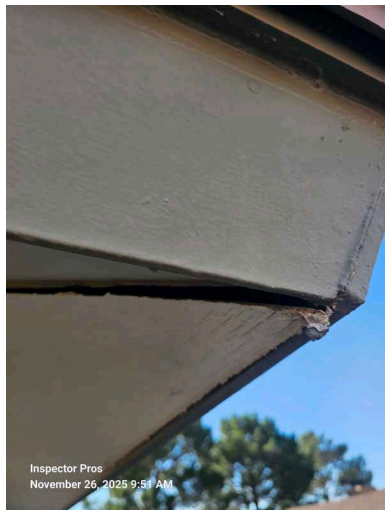
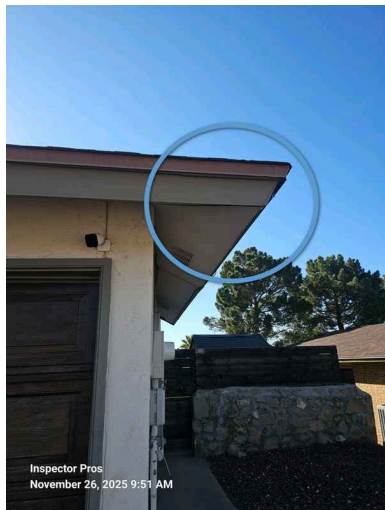
**Implication:** Unsecured soffit can create openings that allow pests or rodents to enter the attic, potentially leading to infestations and damage to insulation or structural components.

Recommendation: Contact a qualified roofing professional.

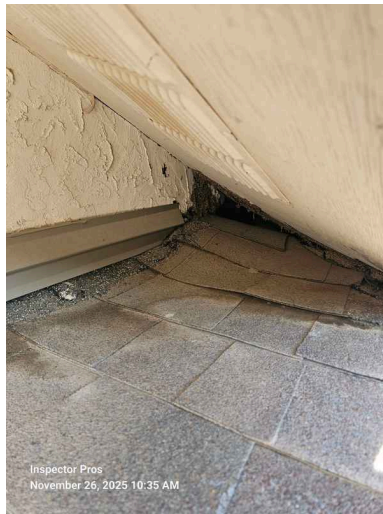
Gaps at the roof-to-soffit transition can allow moisture, pests, and debris to enter the attic or wall cavity, potentially leading to damage or reduced energy efficiency over time.

Recommendation: Contact a qualified professional.

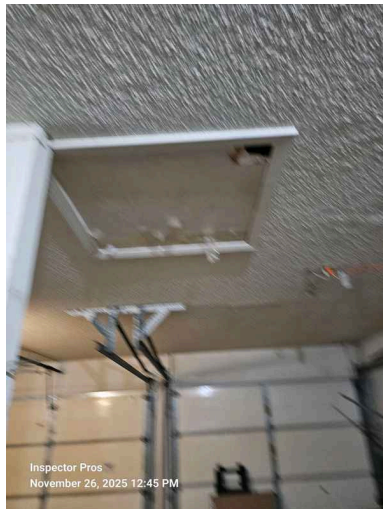
Gaps at the scuttle opening can compromise the required fire separation between the garage and the living space. They can also reduce energy efficiency, allow dust and debris to enter the garage or attic space, and create potential pathways for pests.

Recommendation: Contact a qualified professional.

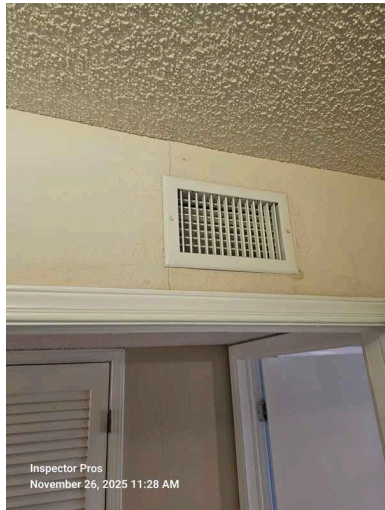
These types of cracks are common as homes age and experience minor movement, and may gradually widen or become more noticeable over time.

Recommendation: Contact a qualified drywall contractor.

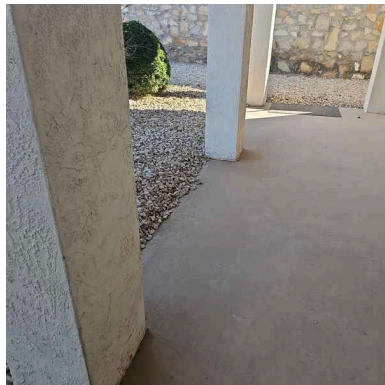
This condition can allow moisture to wick into the siding, accelerate material deterioration, and limit visibility of components behind the siding. Current standards generally recommend a minimum of 2 inches of clearance between siding and hardscape to reduce moisture-related damage.

Recommendation: Contact a qualified professional.

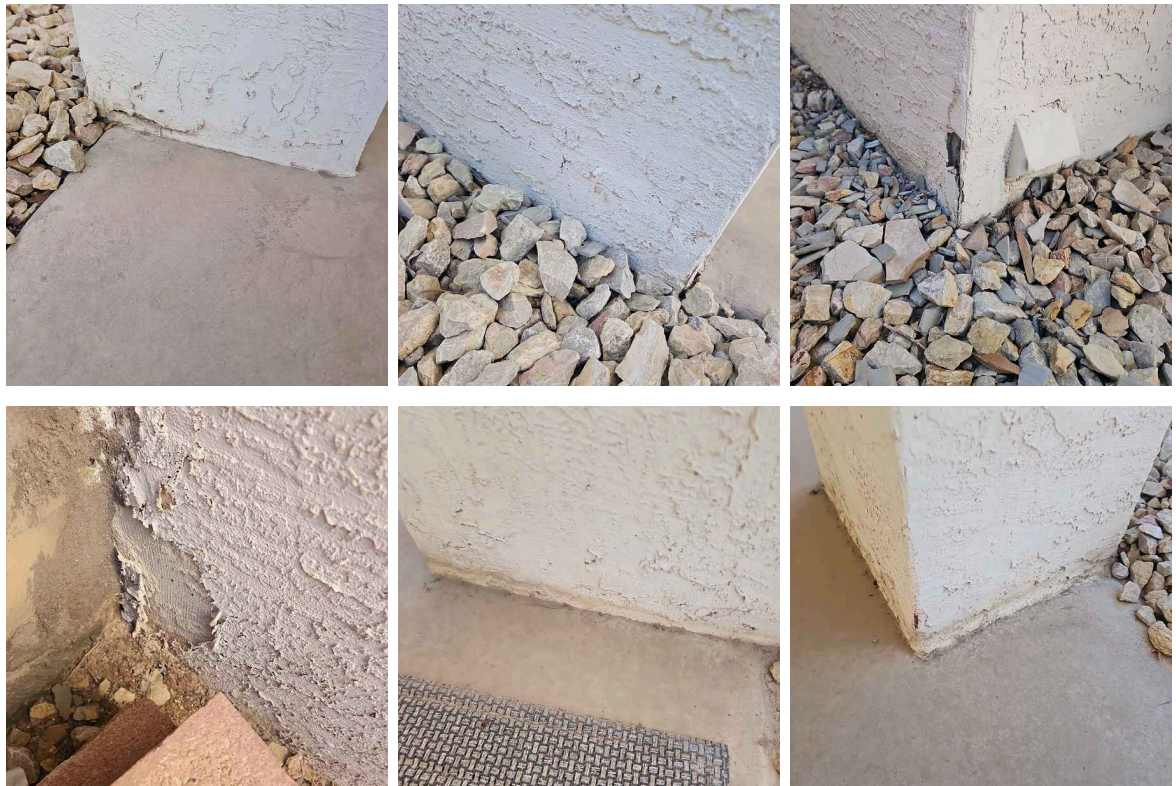
Stucco in direct contact with soil or hardscape is prone to moisture absorption, which can lead to cracking, crumbling, and ongoing deterioration. This condition also limits visibility of the wall system behind the stucco and can contribute to moisture intrusion or concealed damage over time.

Recommendation: Contact a stucco repair contractor

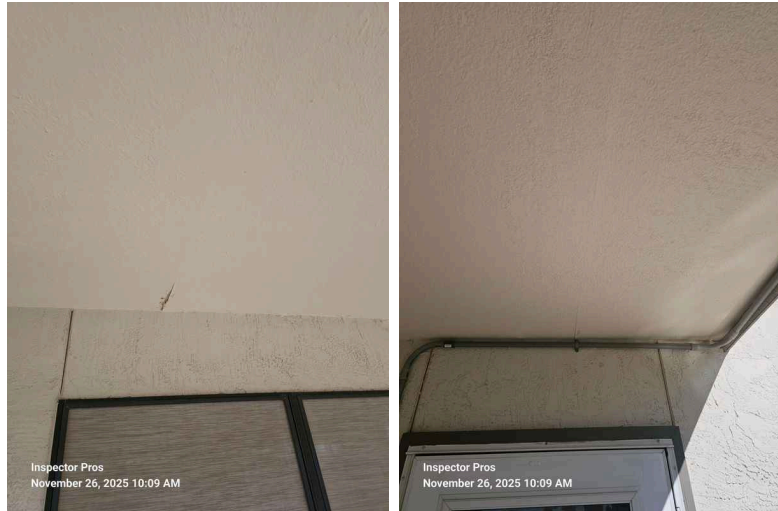
**Implication:** Seam cracks may result from normal settling, temperature and humidity changes, or minor structural movement. While often cosmetic, they can worsen over time and may require repair to restore the appearance and integrity of the wall or ceiling surface.

Recommendation: Contact a qualified driveway contractor.

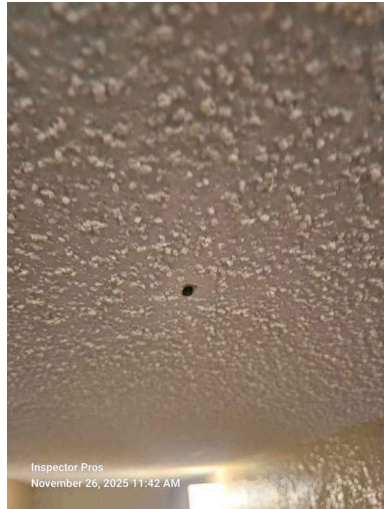
Implication: While generally cosmetic, nail pops can affect the appearance of interior finishes and may indicate minor movement in the structure or aging materials.

Recommendation: Contact a qualified drywall contractor.

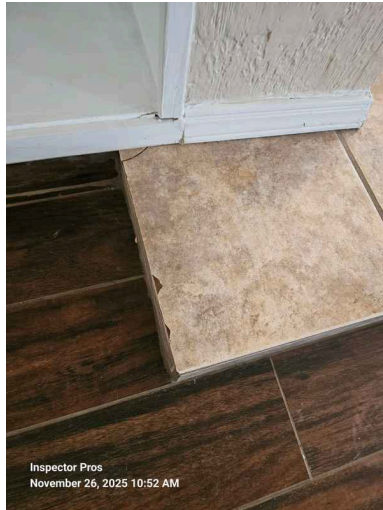
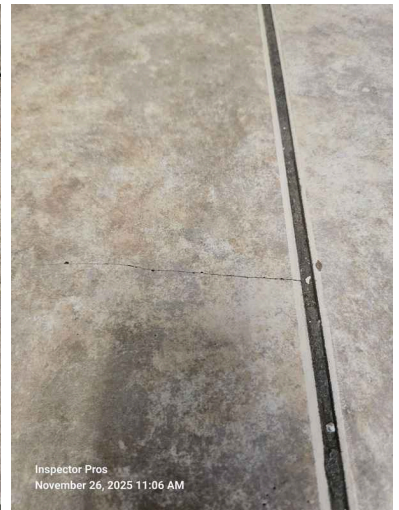
Implication: Damaged floor tiles can present tripping hazards, detract from the overall appearance, and may allow moisture to penetrate beneath the surface, potentially leading to further deterioration

Recommendation: Contact a qualified flooring contractor

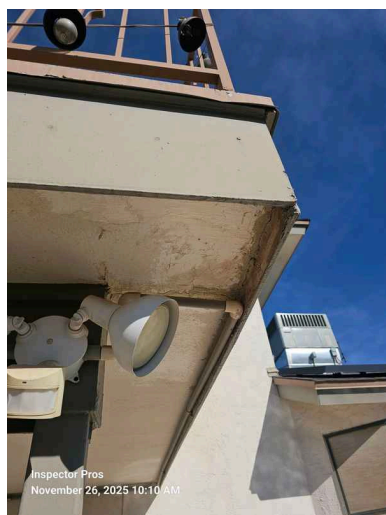
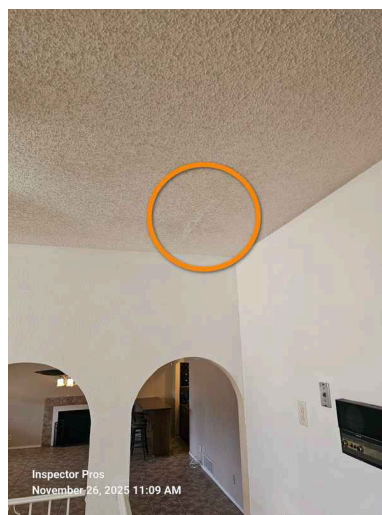
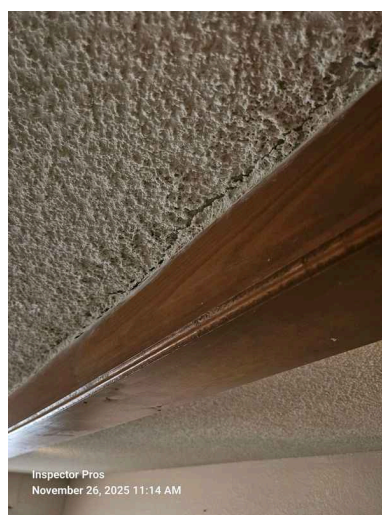
Implication: Moisture stains may indicate previous or intermittent leaks and should be considered active until proven otherwise. These stains can suggest potential roof or plumbing issues that may require further investigation.

Recommendation: Contact a qualified professional.

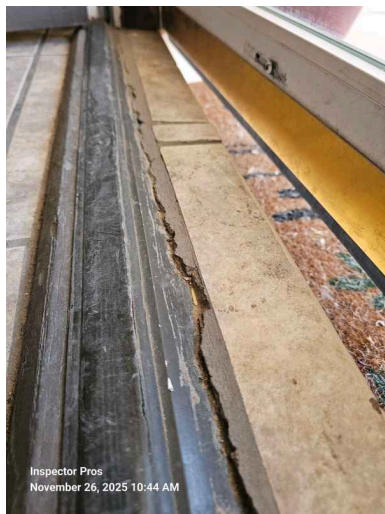
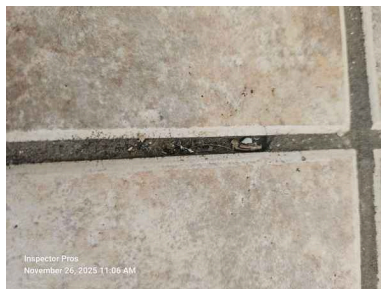
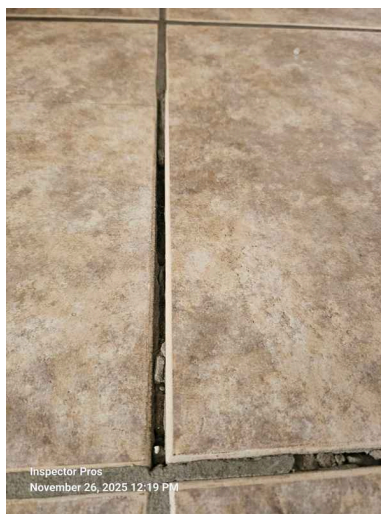
**Implication:** These deficiencies can allow water intrusion beneath the tile surface, potentially leading to deterioration of the subfloor or wall materials and reducing the overall integrity and appearance of the tiled surface.

Recommendation: Contact a qualified flooring contractor

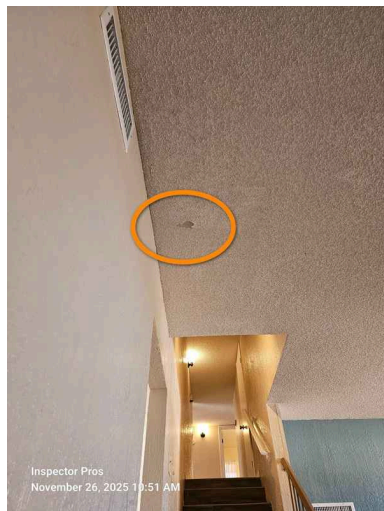
Implication: Damaged drywall can affect the appearance and integrity of interior surfaces and may indicate underlying issues such as impact damage or moisture intrusion. Repairs are recommended as needed by a drywall contractor or other qualified person.

Recommendation: Contact a qualified drywall contractor.

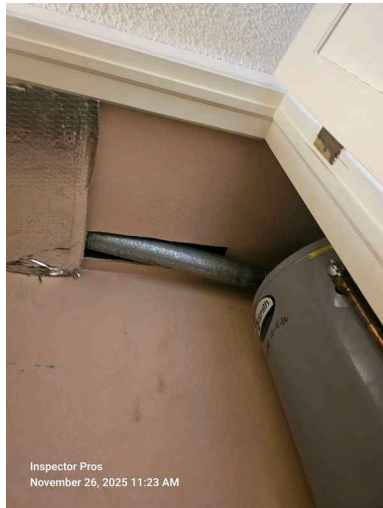
Gaps around the flue can allow heat, moisture, or combustion byproducts to enter the surrounding structure, which may affect fire separation, reduce energy efficiency, or contribute to hidden moisture damage.

Recommendation: Contact a qualified drywall contractor.

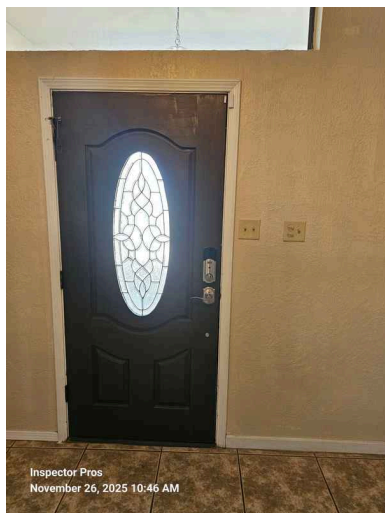
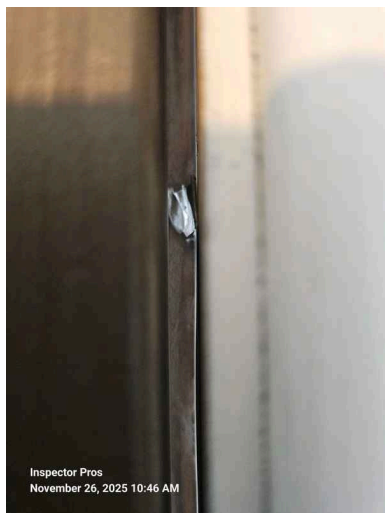
Implication: Visible light indicates gaps that may allow for air drafts, sound transfer, reduced energy efficiency, or loss of privacy between rooms.

Recommendation: Contact a qualified professional.

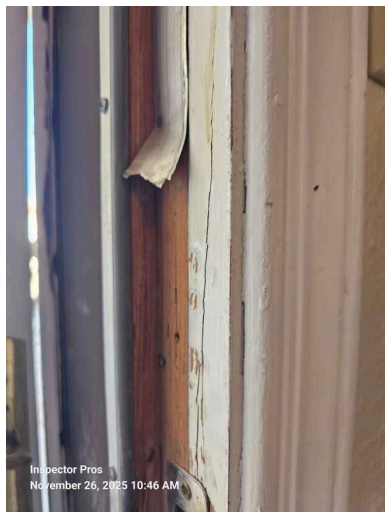
## 3: Weatherstripping: Metal (Possible Safety Hazard)

Implication: Exposed metal edges can pose a safety hazard, potentially causing cuts or injuries to occupants.

Recommendation: Contact a qualified professional.

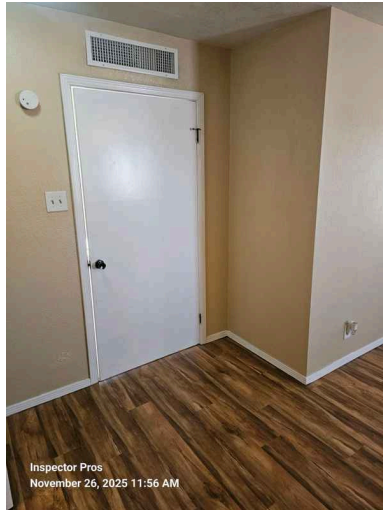
Implication: A door that does not latch correctly can affect security, privacy, and functionality. Adjustments or modifications are needed to ensure proper alignment and reliable operation.

Recommendation: Contact a qualified door repair/installation contractor.

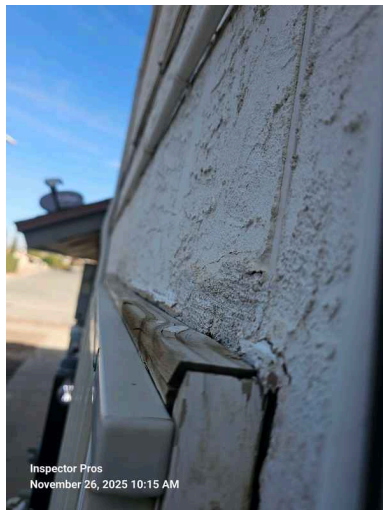
Weathered or unprotected wood is more susceptible to moisture absorption, which can lead to deterioration, rot, and damage over time if not properly sealed or protected.

Recommendation: Contact a qualified professional.

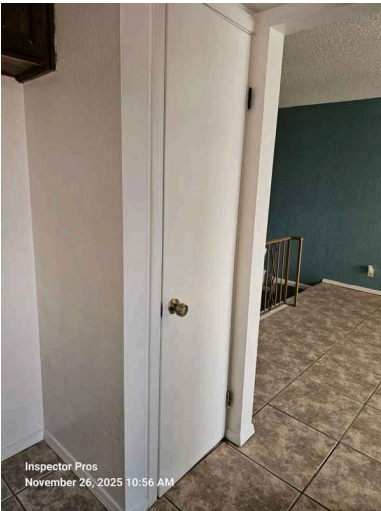
Implication: Binding doors may indicate alignment issues that can affect functionality and cause further wear to components. Adjustments or modifications are likely needed for proper operation.

Recommendation: Contact a qualified handyman.

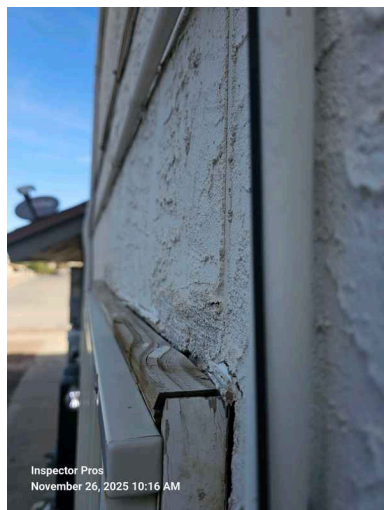
Missing counter flashing can allow water to penetrate behind the door frame, increasing the risk of moisture intrusion, hidden wall damage, and deterioration of building materials over time.

Recommendation: Contact a qualified professional.

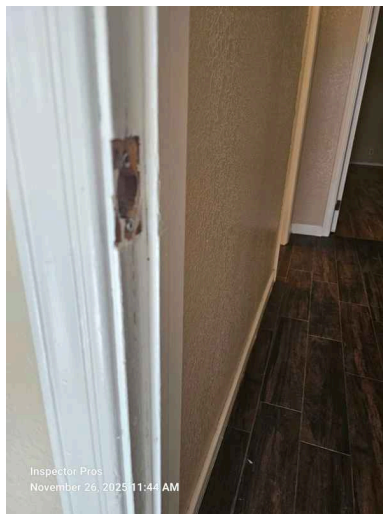
### 13: Door Strike Missing

The door strike plate was missing.

Without a strike plate, the door latch cannot engage properly, reducing security and potentially damaging the door latch or frame over time.

Recommendation: Contact a qualified professional.

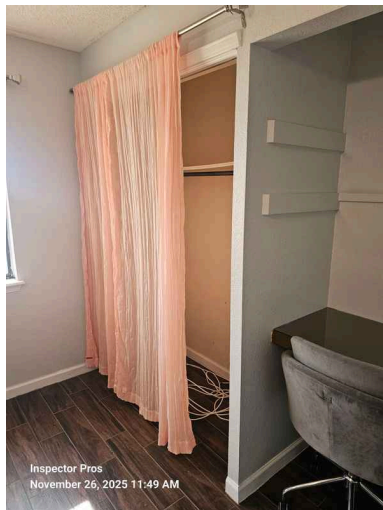
#### 14: Closet Doors Missing

Missing closet doors affect functionality and may leave belongings exposed. Additional framing or alignment issues may be present if doors were previously removed.

Recommendation: Contact a qualified door repair/installation contractor.

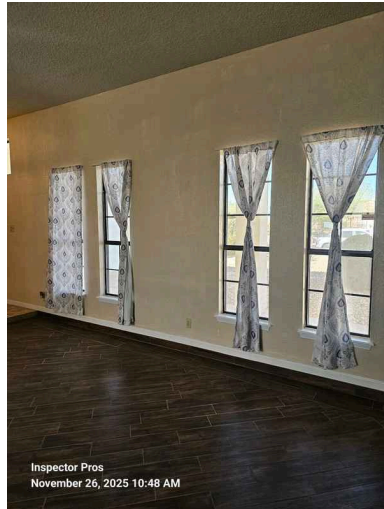
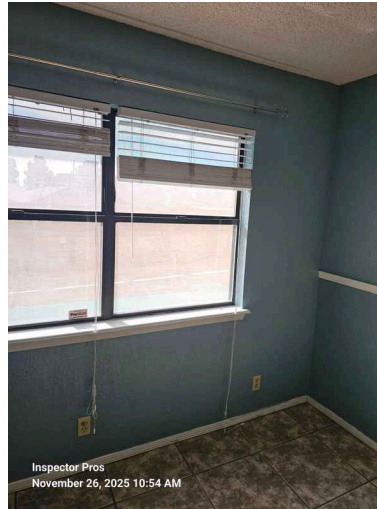
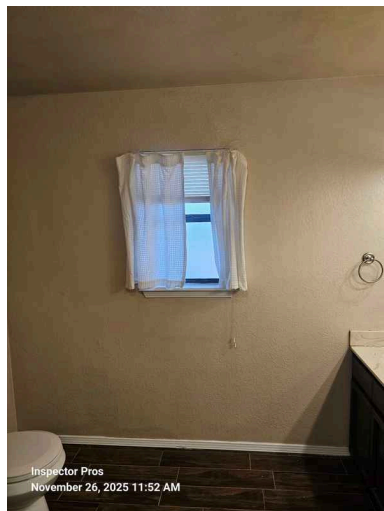
Implication: Difficulty in operating the windows may indicate issues such as failed balance mechanisms, frame warping, or settling. This can affect ventilation, safety, and overall functionality. Repairs or replacement by a qualified contractor is recommended as needed.

Recommendation: Contact a qualified window repair/installation contractor.

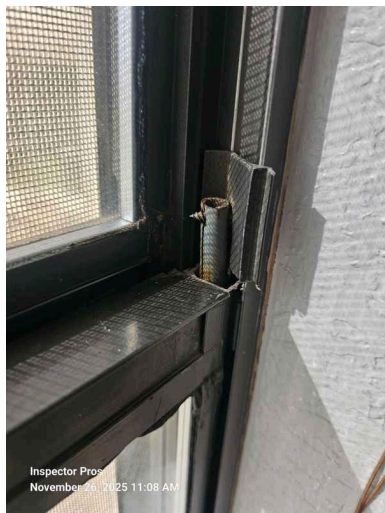
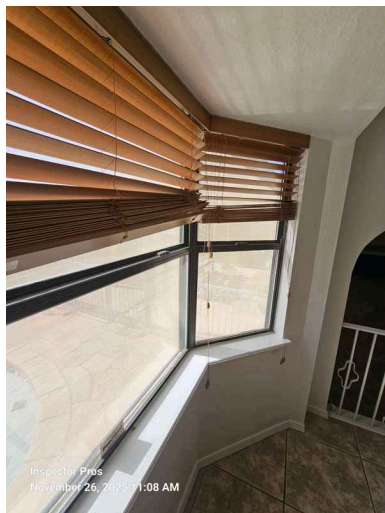
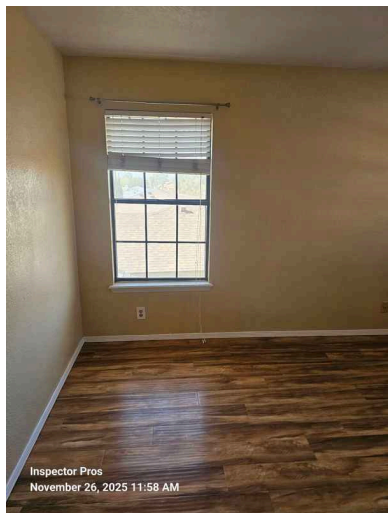
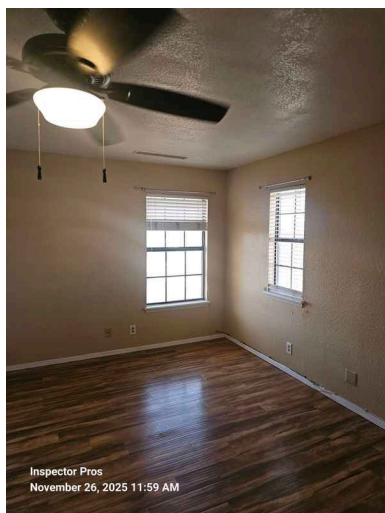
### 3: Balance(s): Deficiencies Present

**Observation:** The referenced window(s) exhibited balance deficiencies. The balance mechanisms, which assist in the smooth operation of the sash and help maintain the window in an open position, were not functioning as intended.

**Implication:** Deficient window balances may result in difficulty operating the window and can cause the sash to close unexpectedly, potentially leading to damage or personal injury.

Recommendation: Contact a qualified window repair/installation contractor.

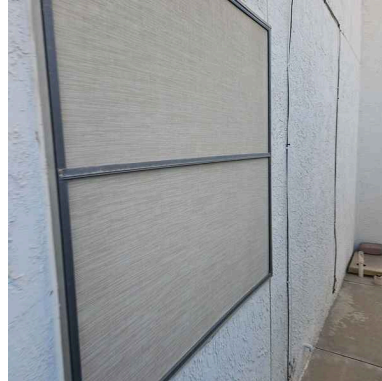
## 6: Screens: Deteriorated

**Observation:** Window screens were observed to be deteriorated in the referenced area(s).

**Implication:** Deteriorated screens can reduce ventilation effectiveness, allow insect entry, and negatively impact the appearance of the windows. Repair or replacement is recommended to restore functionality and maintain comfort.

Recommendation: Contact a qualified window repair/installation contractor.

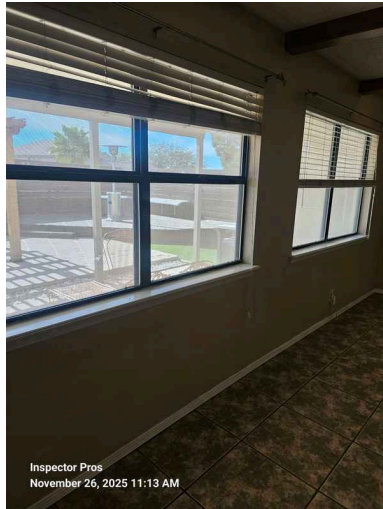
Observation: Noisy springs were noted during the operation of the window(s).

Implication: Noisy window springs may indicate wear, lack of lubrication, or potential failure of the balance mechanism. This can affect smooth operation and may lead to further mechanical issues. Inspection and maintenance or replacement by a qualified professional are recommended.

Recommendation: Contact a qualified window repair/installation contractor.

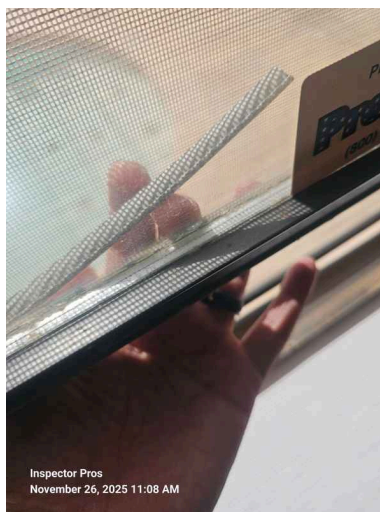
## 8: Double Pain window Exterior Pain Missing

One of the double-pane windows has a missing exterior pane.

With only a single remaining pane, the window offers reduced energy efficiency and may be more susceptible to condensation and temperature transfer.

Recommendation: Contact a qualified window repair/installation contractor.

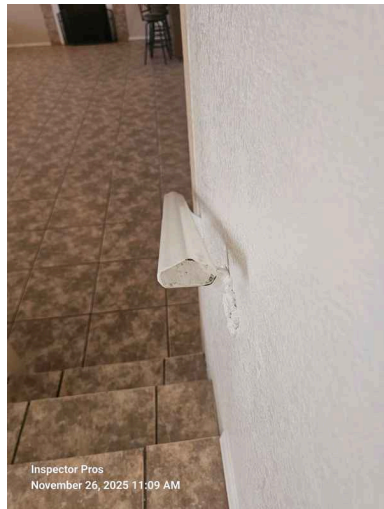
Implication: Handrails without returns can pose a safety hazard, as loose clothing or items may catch on the open ends. Current safety standards recommend that handrails return to the wall to reduce the risk of injury or snagging.

Recommendation: Contact a qualified professional.

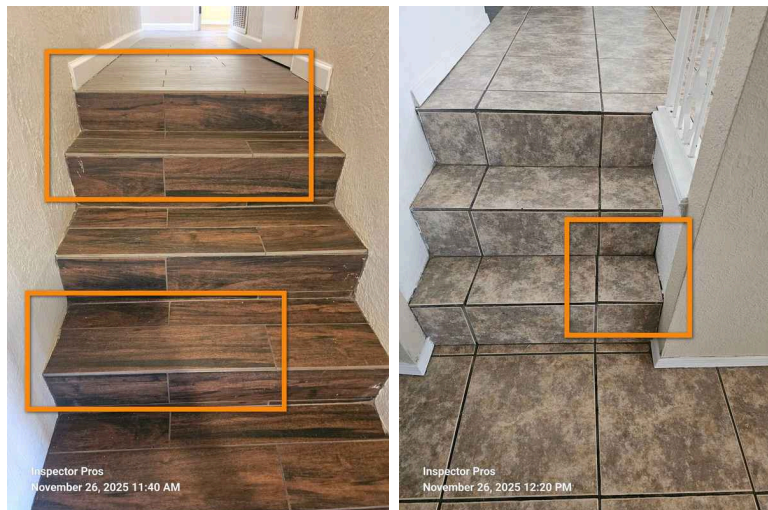
### 3: Tile Loose

Several tiles on the stair treads were noted to be loose during inspection.

Loose tiles can shift underfoot, which may affect usability and increase the likelihood of further tile movement over time.

Recommendation: Contact a qualified flooring contractor

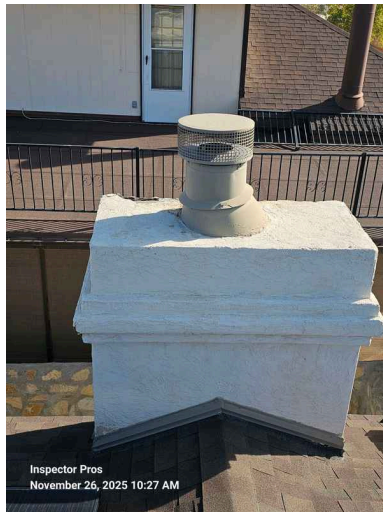
## 2: Crown - Heavy Cracking

Heavy cracking was observed on the chimney crown.

Open cracks at the crown can allow rainwater to enter the chimney structure, which may contribute to moisture-related deterioration of the masonry and mortar over time.

Recommendation: Contact a qualified chimney contractor.

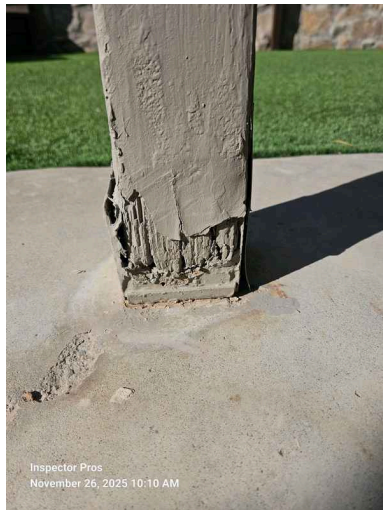
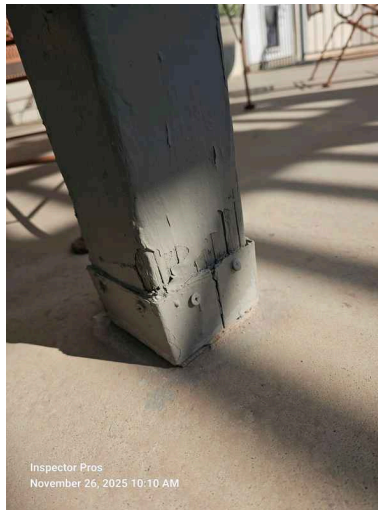
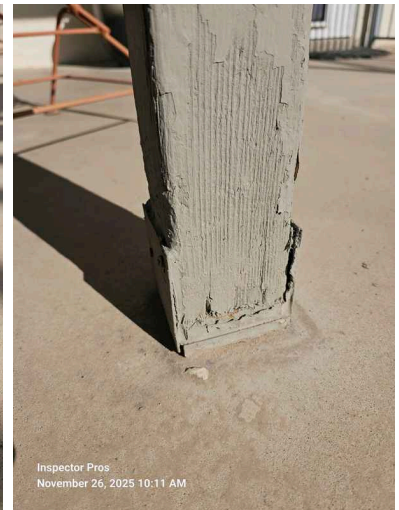
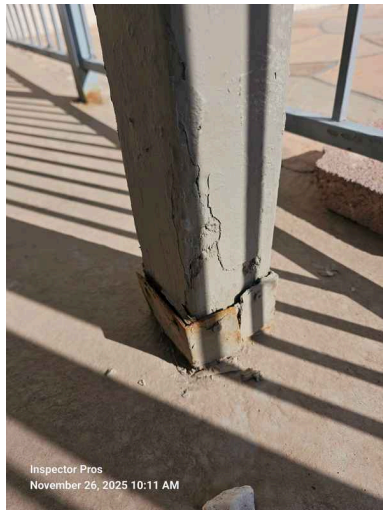
## 2: Balcony Wooden Supports Deteriorated

The wooden supports beneath the balcony show signs of deterioration.

Deteriorated wood can gradually lose strength and may reduce the overall stability and performance of the balcony structure over time.

Recommendation: Contact a qualified professional.

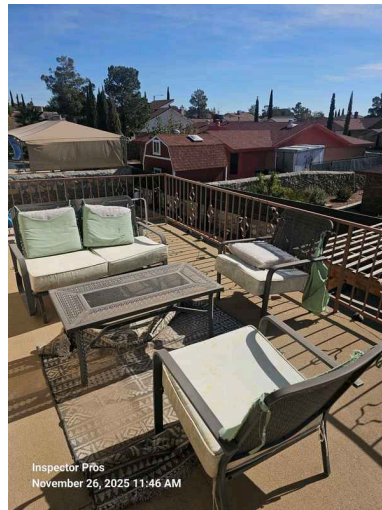
**3: Railing Loose****▲Safety Hazard/Significant Defect**

The balcony railing was noted to be loose during inspection.

A loose railing may not provide full support when leaned on or used, which can affect overall safety and stability.

Recommendation: Contact a qualified professional.

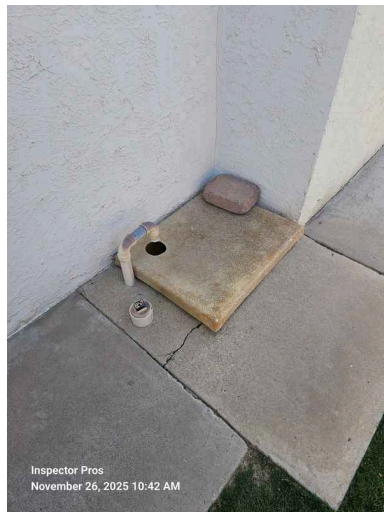
Its placement may increase the chance of someone stepping on the cover, which could lead to loss of balance or potentially falling into the drain area.

Recommendation: Contact a qualified professional.

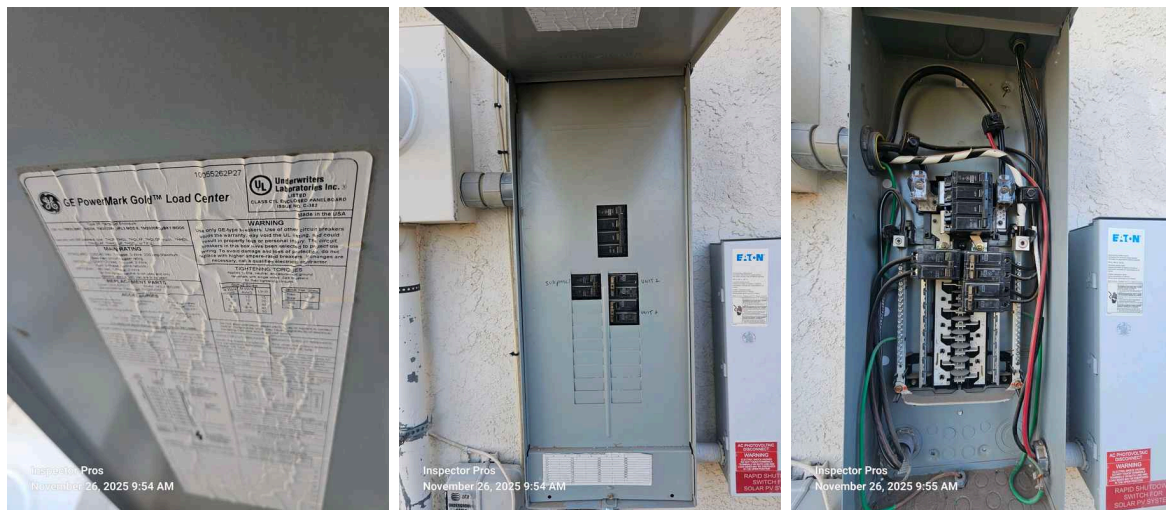
*Main Service Panel Manufacturer: GE*

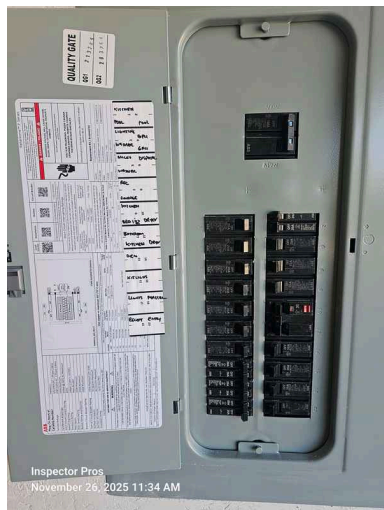
Observation: The legend for the electrical panel was missing, incomplete, or incorrect.

Implication: An inaccurate or absent panel legend can lead to confusion when servicing circuits, increasing the risk of electrical shock or inadvertently shutting off critical systems.

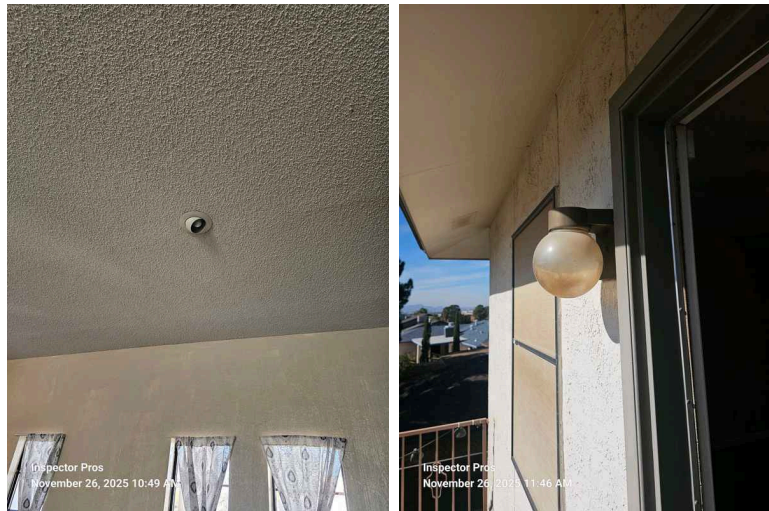
This could be due to something minor, such as burned out or missing bulb(s), or an unknown switch that controls the fixture. However, it may also indicate a more significant issue involving the fixture, wiring, or switch. Without confirmation of functionality, the fixture's condition remains uncertain.

Recommendation: Contact a qualified electrical contractor.

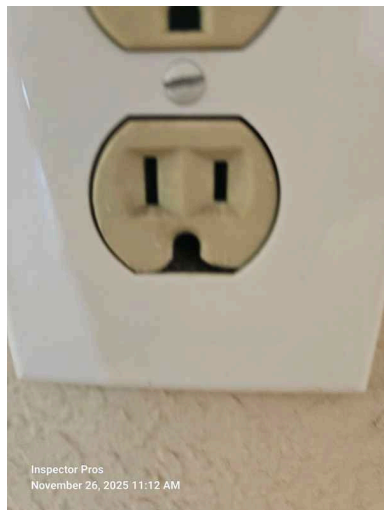
**Implication:** Damaged receptacles can pose a risk of electrical shock, arcing, or fire. Replacement of any damaged receptacles is recommended to be performed by a licensed electrician to ensure safe and reliable operation.

**Recommendation:** Contact a qualified electrical contractor.

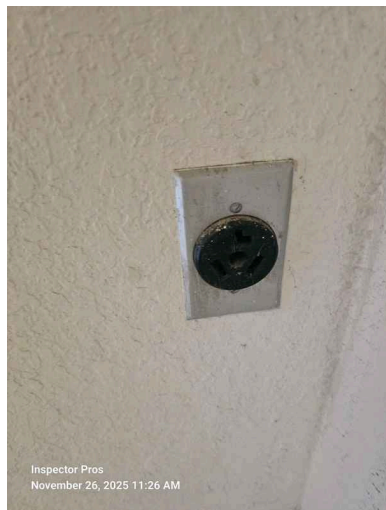
**Implication:** This type of receptacle uses a combined ground and neutral conductor, which can create a potential shock hazard by allowing current to energize the metal housing of connected appliances.

**Recommendation:** Contact a qualified electrical contractor.

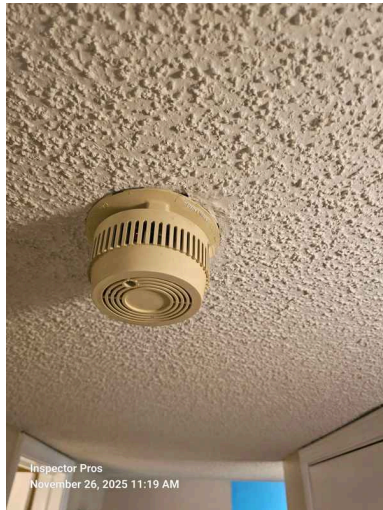
Older smoke alarms may provide reduced reliability and may not respond as effectively as newer models due to age-related wear of internal components.

Recommendation: Contact a qualified professional.

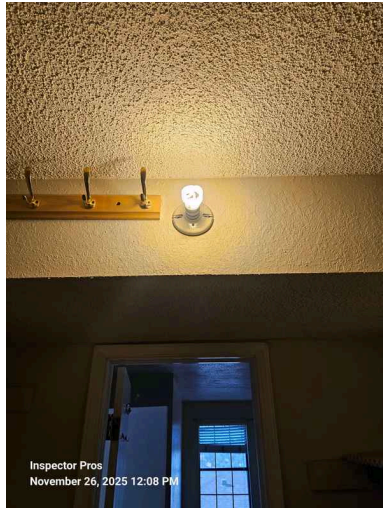
Implication: Exposed bulbs in closets pose a risk of accidental breakage, potential electric shock, and may create a fire hazard if they come into contact with stored items such as linens.

Recommendation: Contact a qualified professional.

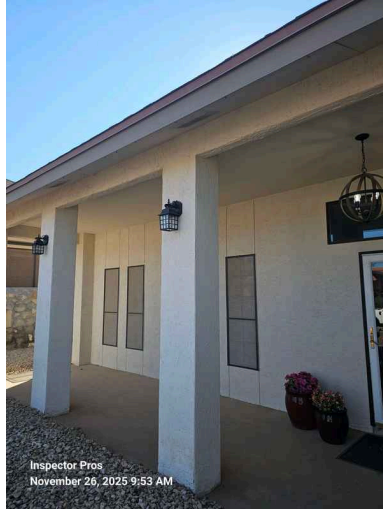
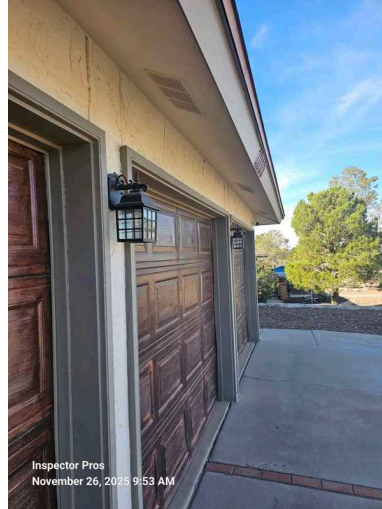
**Implication:** A malfunctioning light fixture may indicate issues with the bulb, wiring, switch, or the fixture itself, affecting illumination and safety. Repairs are recommended to be performed by a qualified person to restore proper operation.

Recommendation: Contact a qualified professional.

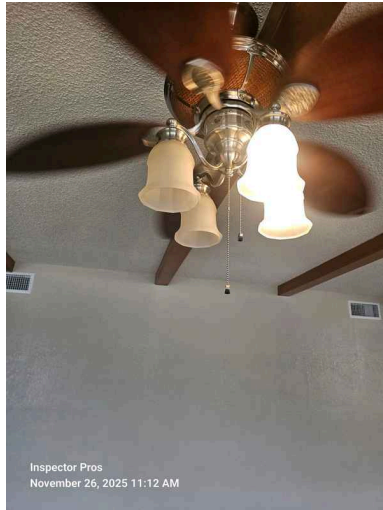
Implication: This may indicate a simple bulb failure or a potential issue with the light fixture or wiring. Further evaluation is recommended if replacing the bulb does not restore function.

Recommendation: Contact a qualified professional.

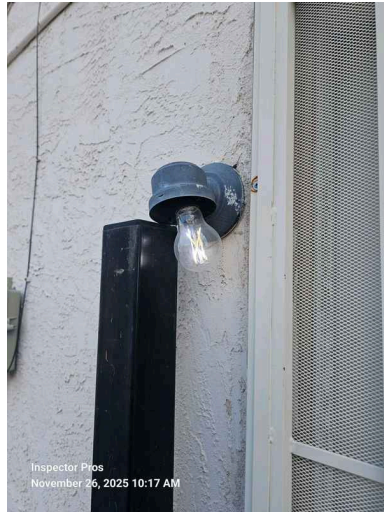
**14: Light Fixture(s): Globes Missing (Exterior)**[Maintenance Item/FYI](#)

Exterior light(s) were present that were missing a proper globe. This can potentially allow for water to reach electrical components causing damage. The installation of globes is recommended to be performed by a qualified person.

Recommendation: Contact a handyman or DIY project

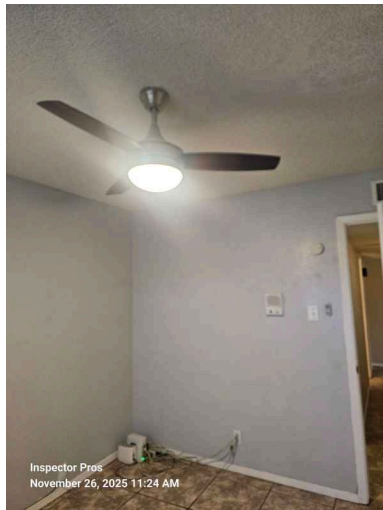
Non-operation with the remote may indicate an issue with the remote, batteries, receiver, or fan control system, affecting normal use.

Recommendation: Contact a qualified professional.

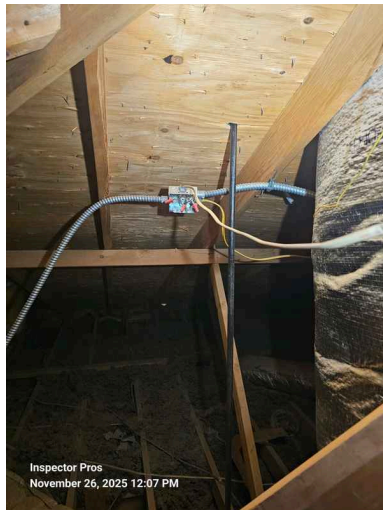
### 19: Junction Box Cover plate missing Exposed Splices

A junction box was found without a cover plate, leaving wire splices exposed.

Exposed splices can be more vulnerable to accidental contact or disturbance, which may affect the reliability and safety of the electrical connection.

Recommendation: Contact a qualified electrical contractor.

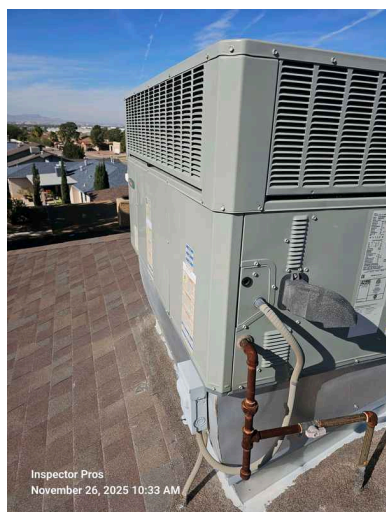
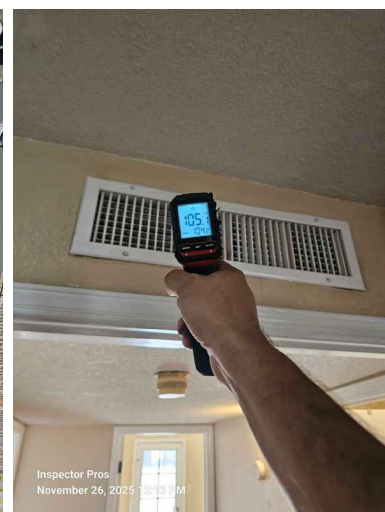
*Manufacturer(s) and Age 2:* Lennox, 2019 -  
The typical life expectancy is approximately 13-15 years.

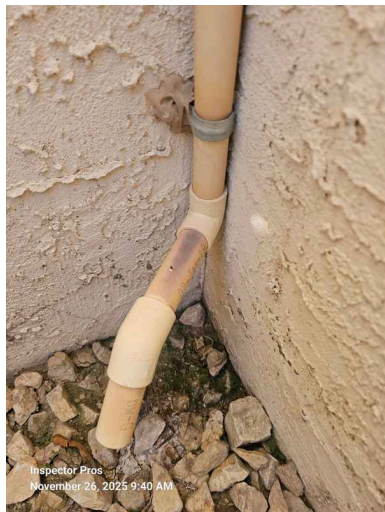
## 2: Condensate Drain PVC not Painted Showing Signs of UV Damage

The condensate drain's PVC piping is not painted and shows signs of UV-related surface deterioration.

Unprotected PVC exposed to sunlight can gradually weaken or become brittle over time, which may reduce the durability of the drain line.

Recommendation: Contact a qualified professional.

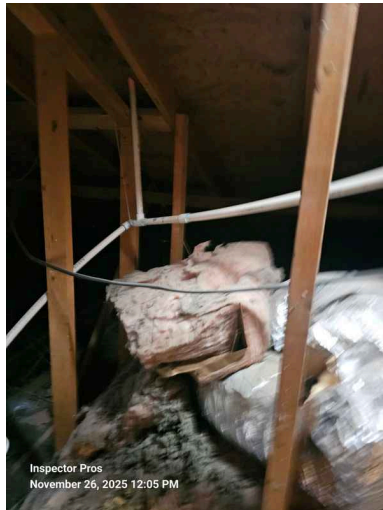
Shared condensate lines can allow one unit's drainage or pressure to influence the other, which may affect proper condensate flow and system performance.

Recommendation: Contact a qualified professional.

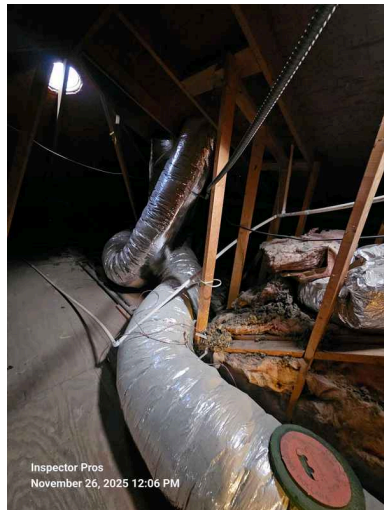
**4: Condensate Drains not properly Supported****Recommendation**

Insufficient support can allow the lines to sag or shift, which may impact proper drainage and overall system performance over time.

Recommendation: Contact a qualified professional.

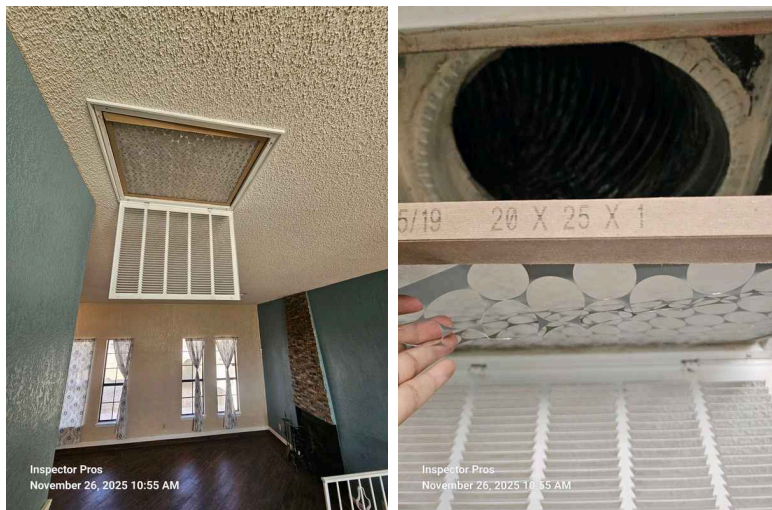
*Filter(s) Size and Location:* 20 X 25, Dining room by stairs -

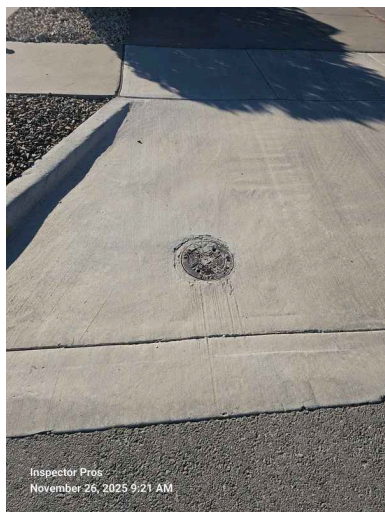
*Location of Water Meter:* Front

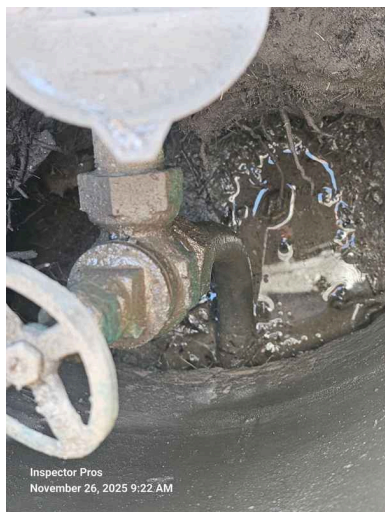
**1: Leak at Meter Utility Side****➡Recommendation**

A leak was observed at the meter on the utility side.

A leak in this area can result in unnecessary water loss and may indicate wear or deterioration in the utility-side components.

Recommendation: Contact a qualified professional.

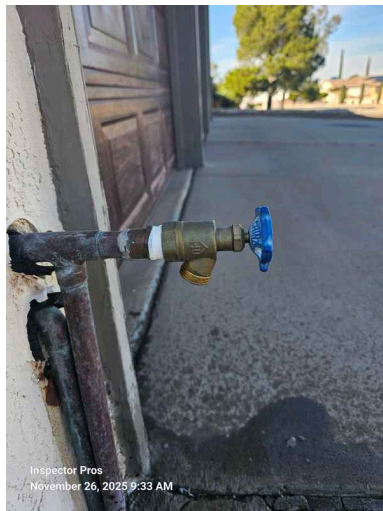
### 1: Anti Siphon Cap: Missing

**Observation:** The anti-siphon cap was missing from the referenced spigot(s).

**Implication:** Without an anti-siphon device, there is a risk of backflow contamination entering the potable water supply, particularly if a hose is submerged in a contaminated source.

**Recommendation:** Contact a qualified professional.

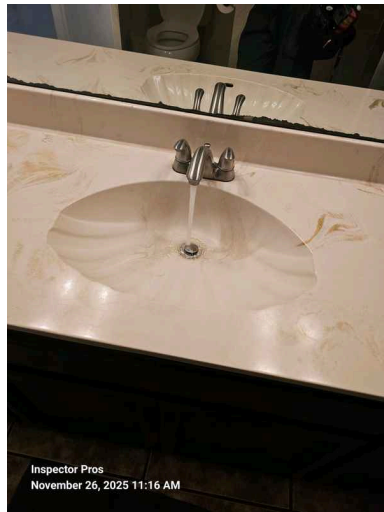
**Observation:** The pop-up stopper on the sink was not functioning properly. Issues may include improper connection, failure to seal, or other defects.

**Implication:** A malfunctioning pop-up stopper can affect the sink's ability to retain or drain water properly, reducing functionality and convenience. Repairs are recommended to be performed by a qualified person to ensure proper operation.

Recommendation: Contact a qualified handyman.

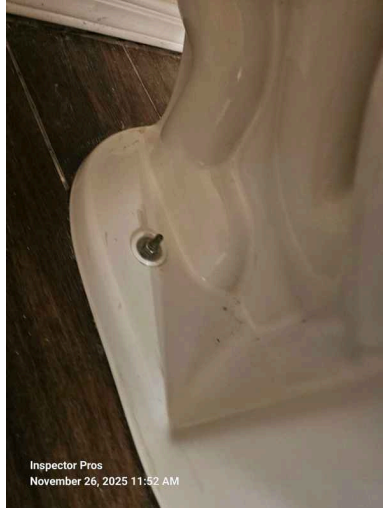
### 3: Toilet: Sanitary Caps Missing

**Implication:** The exposed bolts are considered unsanitary, as they can collect bacteria and make cleaning more difficult. This condition may affect hygiene around the toilet base.

**Recommendation:** Contact a qualified handyman.

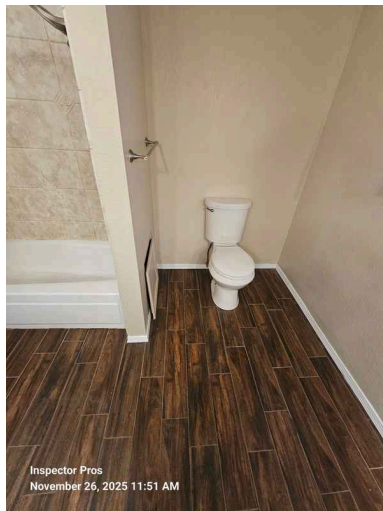
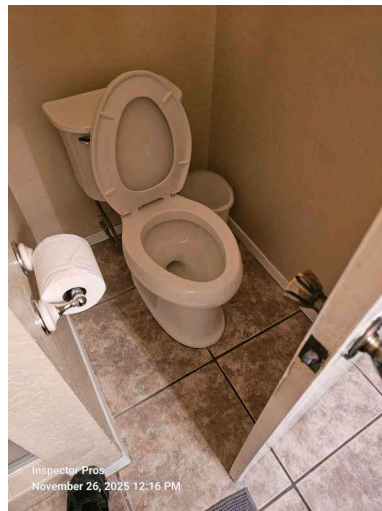
#### 4: Toilet: Loose at Floor

**Observation:** The toilet was loose at the floor anchor bolts.

**Implication:** A loose toilet may compromise the seal between the toilet and the wax ring, potentially allowing water or sewer gas to leak into the surrounding area.

Recommendation: Contact a qualified plumbing contractor.
