## HOME INSPECTION REPORT

1234 Main Street  
Socorro TX 79927

# PROPERTY INSPECTION REPORT FORM

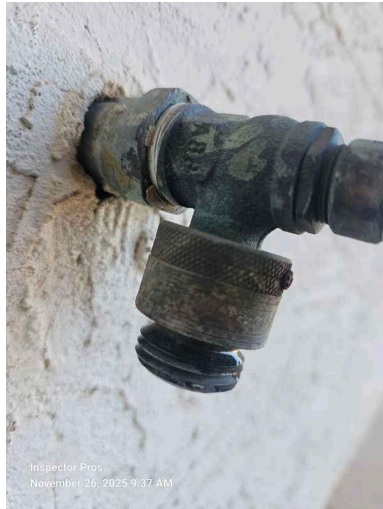
### 5: Anti-Siphon Cap: Leaking

Observation: A leak was present from the anti-siphon cap on the referenced spigot(s).

Recommendation: Repairs or replacement of the spigot(s) as needed is recommended to be performed by a licensed plumber to prevent water waste and potential water damage.

Recommendation: Contact a qualified plumbing contractor.

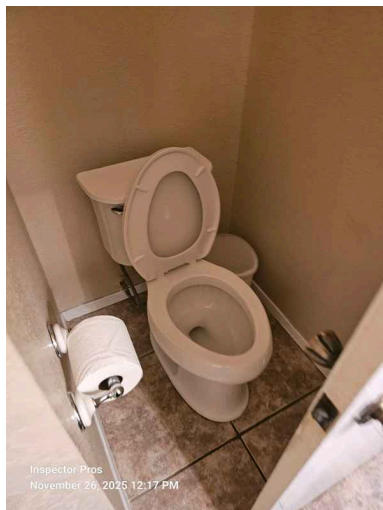
A fill valve that does not operate correctly may affect the toilet's ability to refill consistently, which can impact normal function and water usage.

Recommendation: Contact a qualified plumbing contractor.

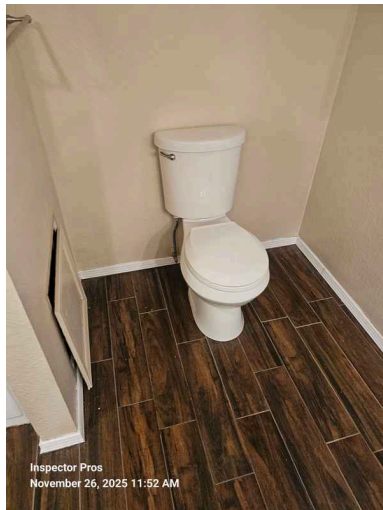
Improper flushing and fill valve performance can limit the toilet's ability to clear the bowl effectively and may affect normal water flow and operation.

Recommendation: Contact a qualified plumbing contractor.

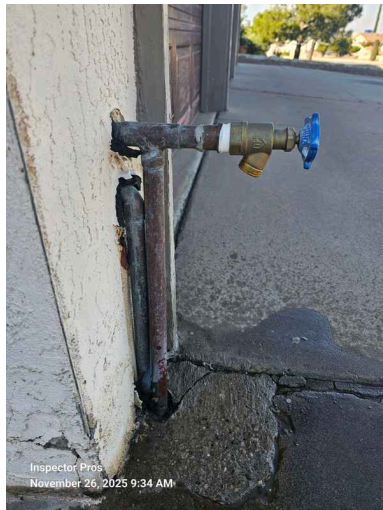
Exposed copper piping was observed in areas subject to cooler temperatures.

Unprotected piping in these locations may be more vulnerable to heat loss and potential freezing conditions during colder weather.

Recommendation: Contact a qualified professional.

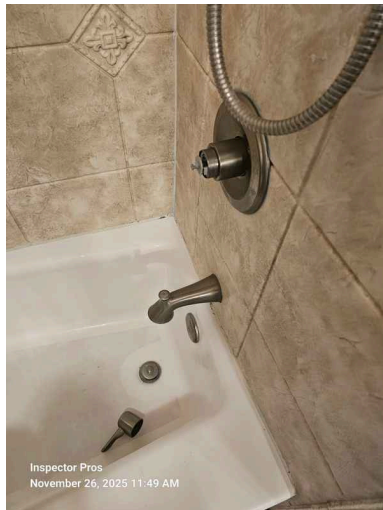
### 9: Shower Handle Loose

The shower handle was noted to be loose during operation.

A loose handle can affect smooth operation and may allow gradual wear of the internal components over time.

Recommendation: Contact a qualified professional.

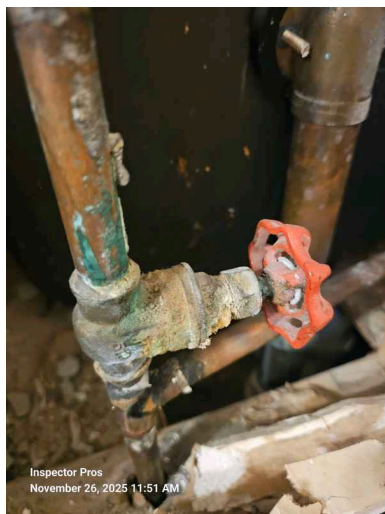
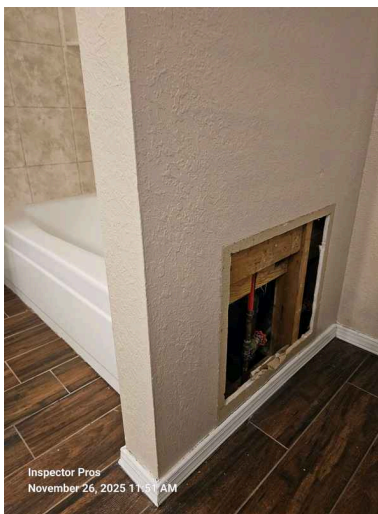
**10: Tub Shut Offs Corroded****Recommendation**

The tub shutoff valves were observed to have corrosion on their surfaces.

Corrosion on shutoff valves can indicate age or moisture exposure and may affect long-term reliability or ease of operation.

Recommendation: Contact a qualified plumbing contractor.

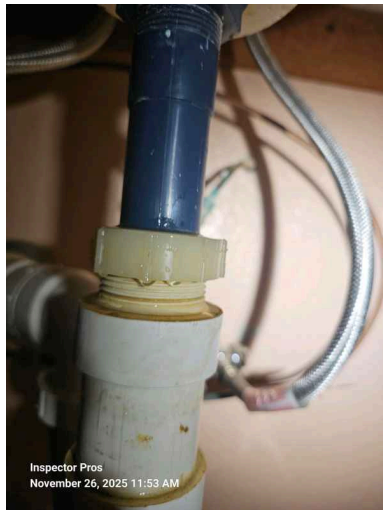
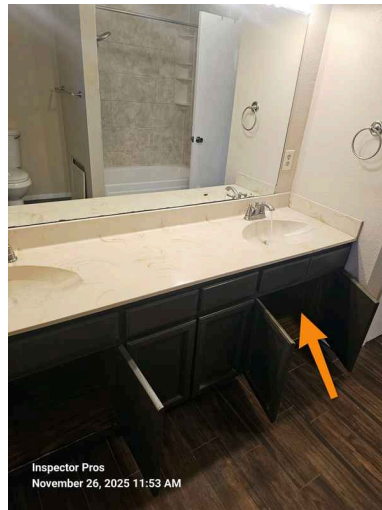
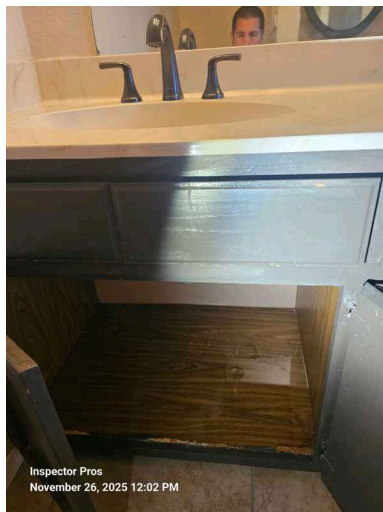
## 1: DWV Pipe(s): Active Leaking

Leaking was observed from the drain/waste piping in the referenced area.

Active leakage can lead to moisture accumulation, which may contribute to material deterioration or staining in the surrounding area over time.

Recommendation: Contact a qualified plumbing contractor.

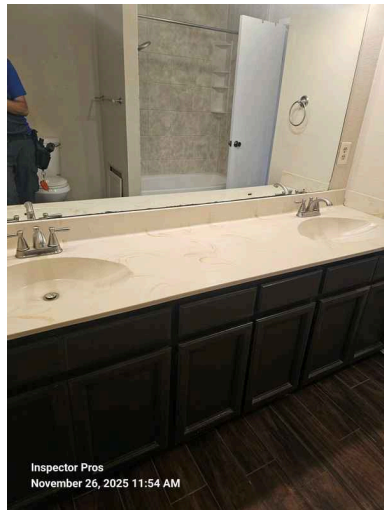
This may indicate a partial blockage or buildup within the drain line, which can result in slow water evacuation, potential backups, and unsanitary conditions if not addressed.

Recommendation: Contact a qualified plumbing contractor.

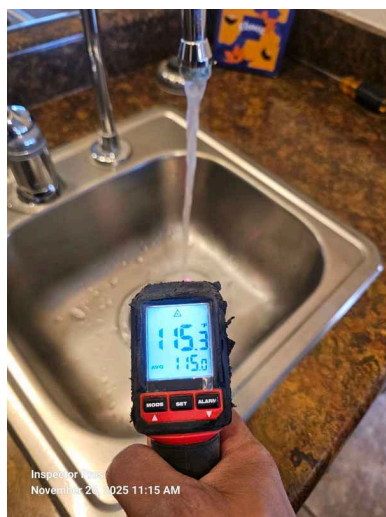
The maximum recommended water temperature produced at faucets in the home is 120 degrees due to the possibility of scalding at temperatures above this.

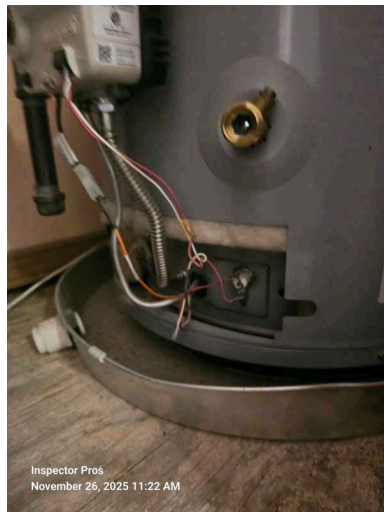
A missing cover plate can leave internal components exposed, which may affect proper burner operation and overall appliance performance.

Recommendation: Contact a qualified electrical contractor.

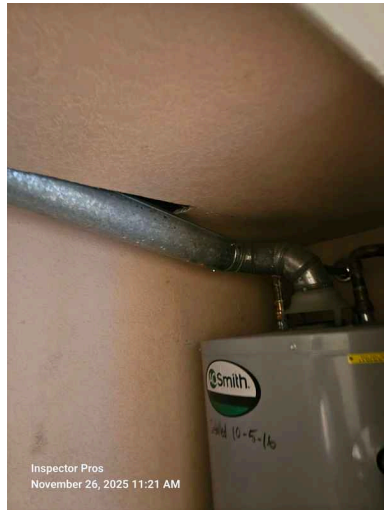
A missing cover plate can leave internal components exposed, which may affect proper burner operation and overall appliance performance.

Recommendation: Contact a qualified professional.

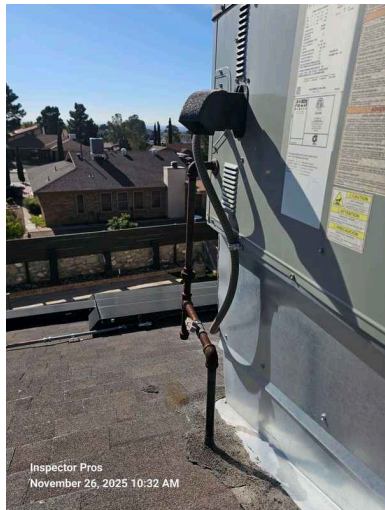
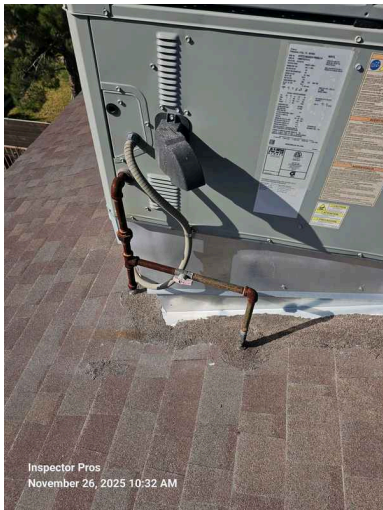
Rust on unprotected gas piping can indicate ongoing exposure to moisture and may affect the long-term durability of the piping material.

Recommendation: Contact a qualified professional.

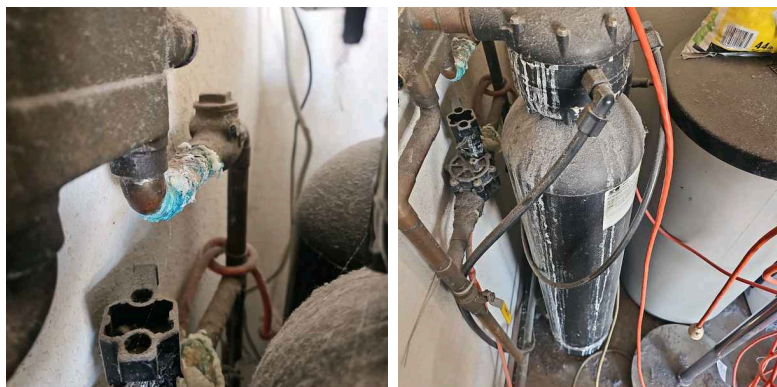
The water softener showed signs of corrosion and water staining, indicating possible past or present leakage.

Corrosion and staining can suggest moisture exposure over time and may affect the unit's overall condition or performance.

Recommendation: Contact a qualified professional.

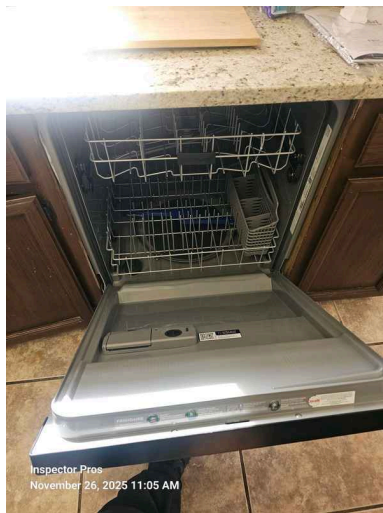
**1: Dishwasher: Not Functional****➡Recommendation**

**Implication:** A non-functional dishwasher may indicate electrical, mechanical, or control system issues, rendering the appliance unusable.

**Recommendation:** Contact a qualified appliance repair professional.

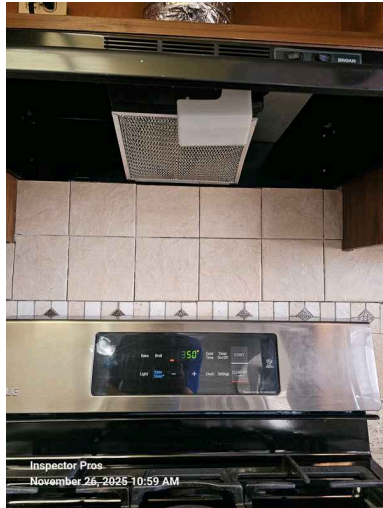
**Implication:** This may be due to a simple issue such as a burned-out bulb, or it could indicate a more significant problem with the fixture or electrical components.

**Recommendation:** Contact a qualified professional.

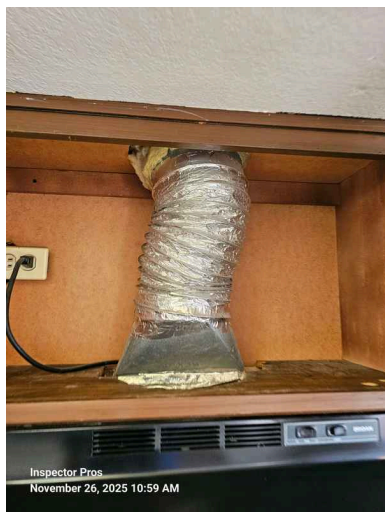
Flex duct material can be more prone to grease buildup and airflow restriction, which may reduce the efficiency of the kitchen ventilation system over time.

Recommendation: Contact a qualified HVAC professional.
