## TEXAS NEW CONSTRUCTION

1234 Main Street  
Socorro TX 79927

# PROPERTY INSPECTION REPORT FORM

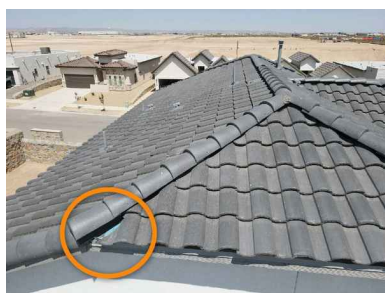
A roof tile was observed to be loose with visible underlayment exposed beneath it. This condition allows water infiltration potential and compromises the roof's weather protection. A roofing professional should inspect the affected area, reset or replace the loose tile, and verify that the underlayment is intact and properly secured.

Recommendation: Contact your builder.

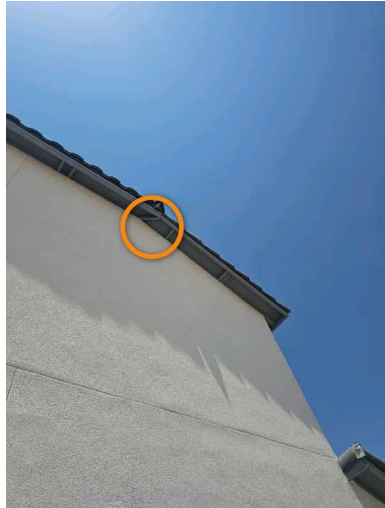
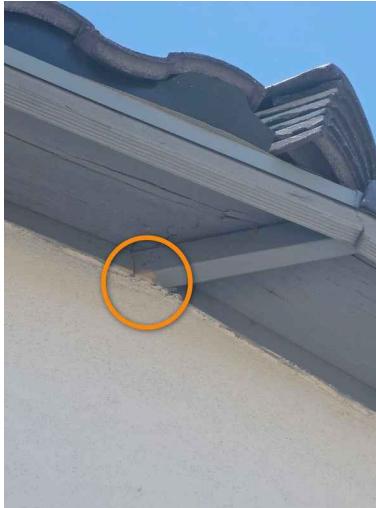
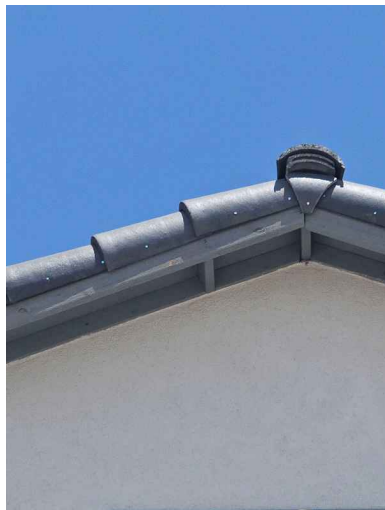
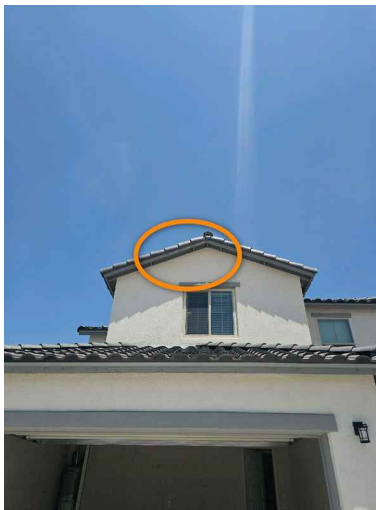
Areas of fascia/soffit were observed missing paint. Recommend builder paints areas to prevent premature deterioration of fascia.

Recommendation: Contact your builder.

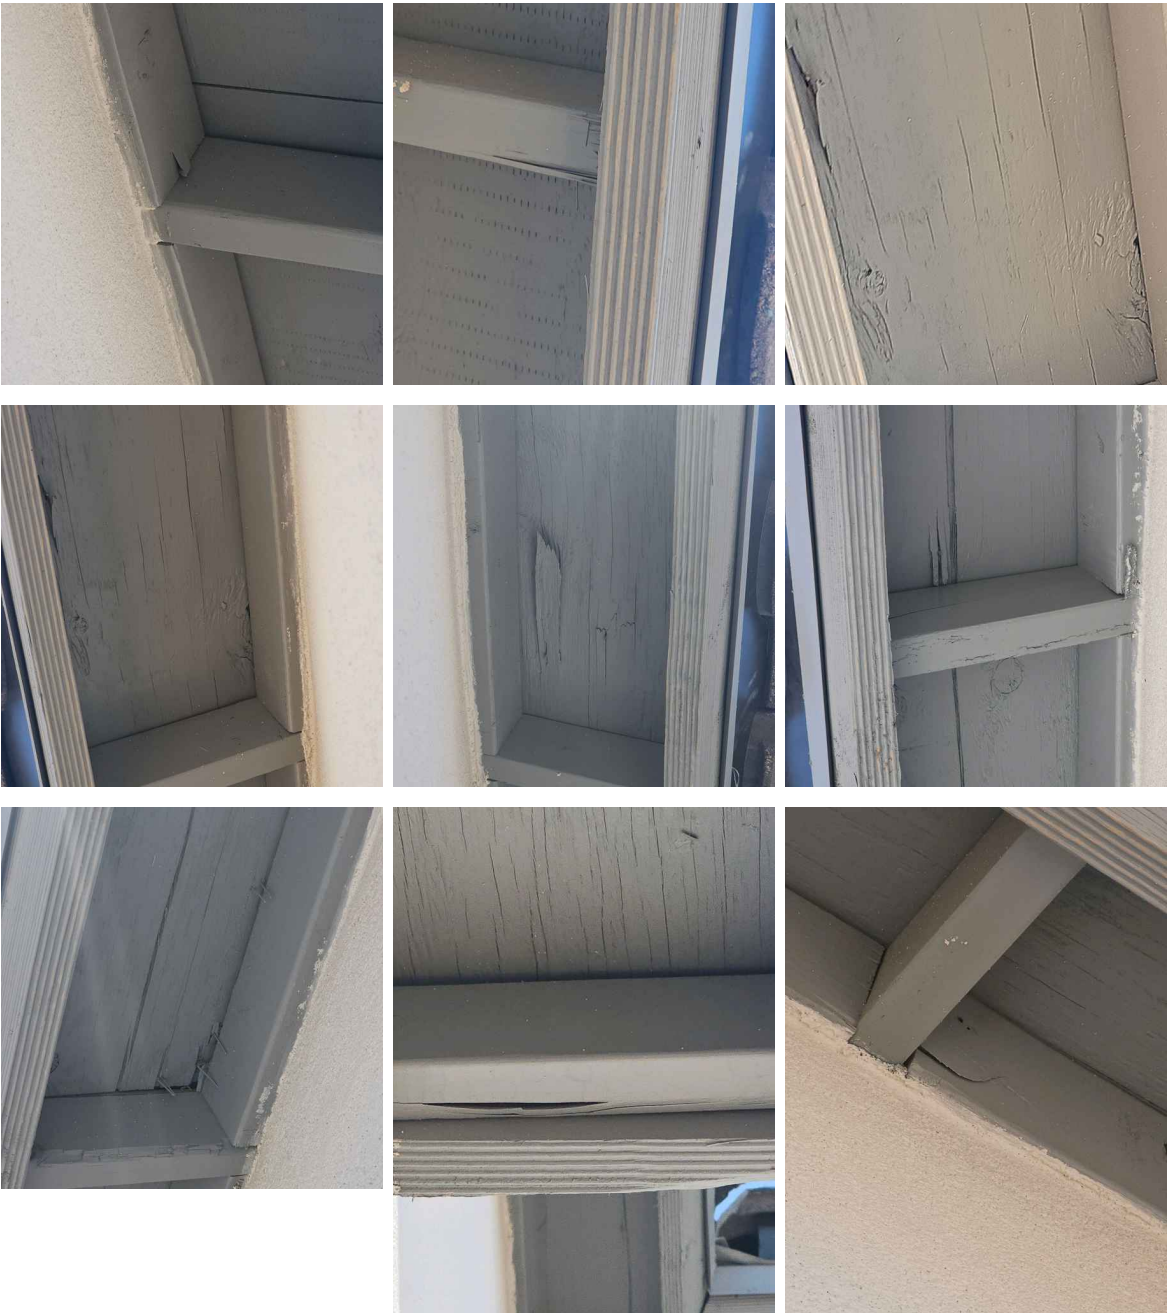
Nails are protruding through the sides of 2x4 framing members on the uncovered eave, causing visible cracks in the wood. This condition was observed during inspection of the roof structure. Protruding fasteners can create puncture hazards and allow water infiltration into the wood framing, potentially leading to rot and structural compromise. A carpentry contractor should inspect the affected framing, remove or countersink the protruding nails, and repair any cracked wood members as needed.

Recommendation: Contact your builder.

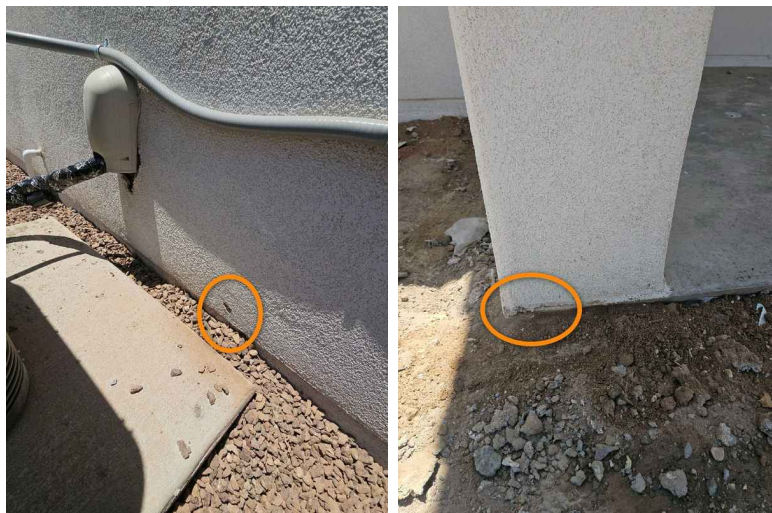
Damage and cracking were observed in portions of the stucco cladding at time of inspection. Cracked or damaged stucco can allow moisture intrusion behind the exterior finish, potentially leading to deterioration of underlying materials if not corrected. Repair of the affected stucco areas is recommended to help limit moisture intrusion.

Recommendation: Contact your builder.

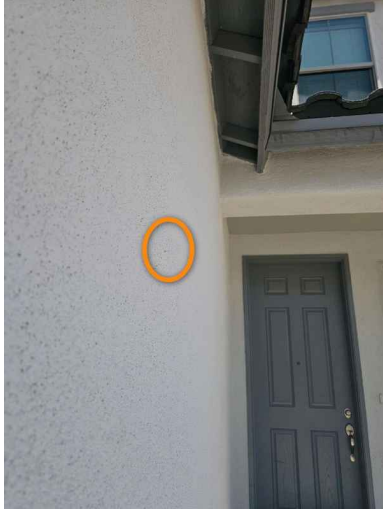
Stucco lath was observed visible at time of inspection. Exposed lath can allow moisture intrusion and may lead to deterioration of the stucco system if not addressed. Repairing the affected areas to provide proper coverage and protection is recommended.

Recommendation: Contact your builder.

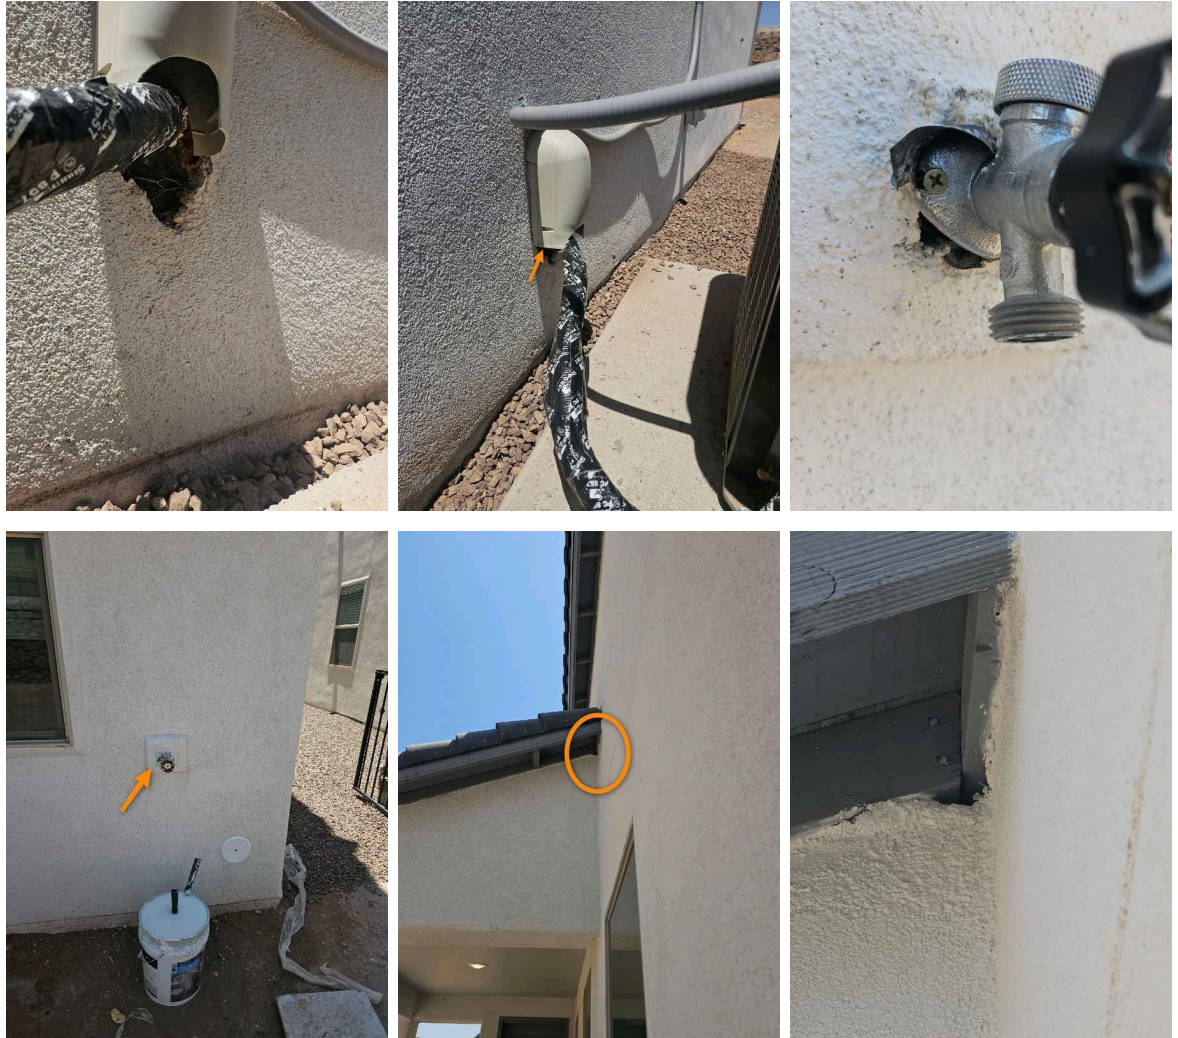
Gaps / unfinished stucco was observed in multiple areas. Recommend sealing gaps to prevent moisture intrusion and premature deterioration.

Recommendation: Contact your builder.

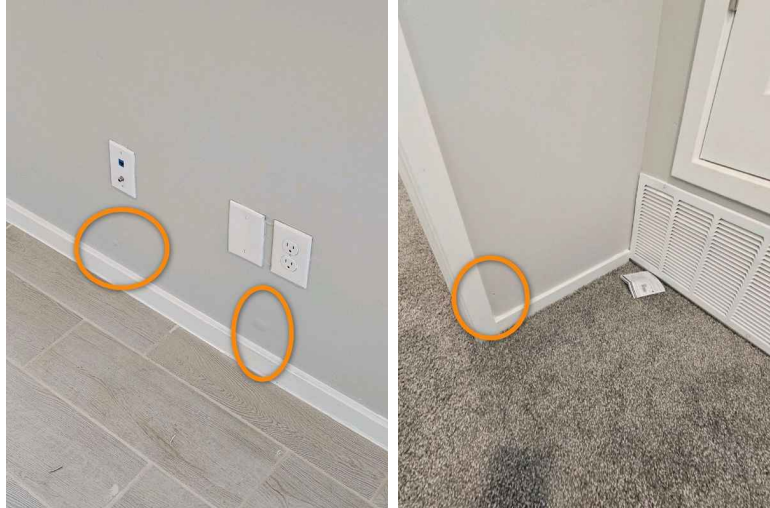
Drywall nail pops were observed in interior walls and ceilings. This condition is common in new construction but can affect the finished appearance. Recommend builder evaluate and repair to restore proper surface condition.

Recommendation: Contact your builder.

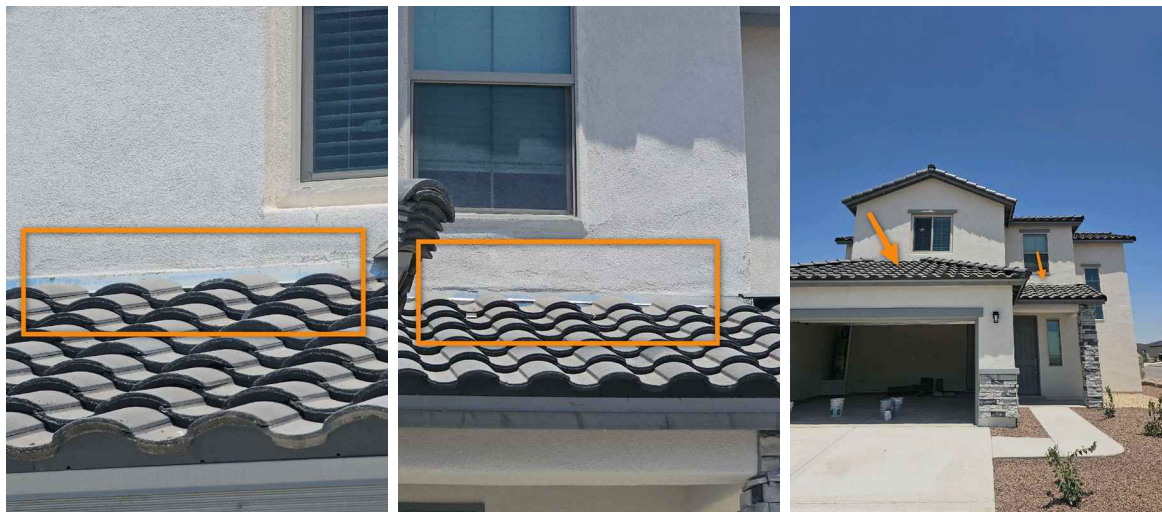
Wall flashing observed without paint finish during inspection. Unpainted metal flashing is susceptible to corrosion and rust, which can compromise its water-shedding ability and lead to moisture intrusion into wall cavities. The flashing should be painted to protect the metal and ensure proper weatherproofing performance.

Recommendation: Contact your builder.

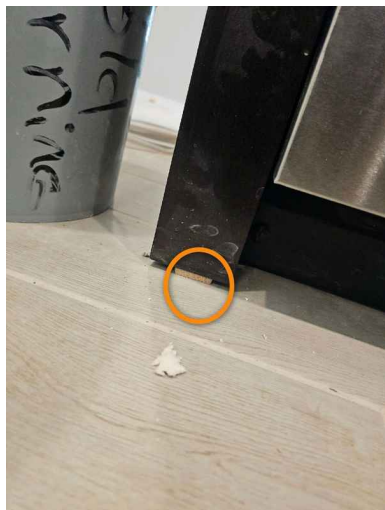
An island cabinet shim is visible and exposed. Cabinet shims are temporary spacing devices used during installation to level cabinetry; they should typically be concealed or removed after final positioning. Visible shims indicate incomplete finishing work and may suggest the cabinet installation requires final adjustments or trim work to properly conceal these spacing elements.

Recommendation: Contact your builder.

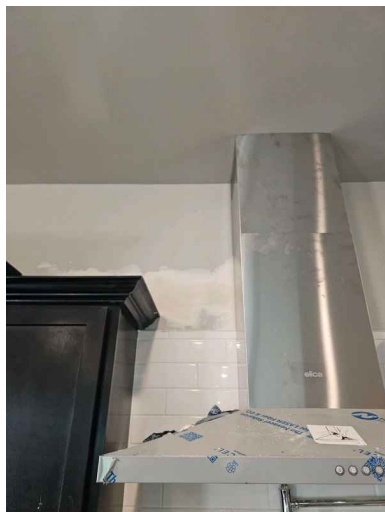
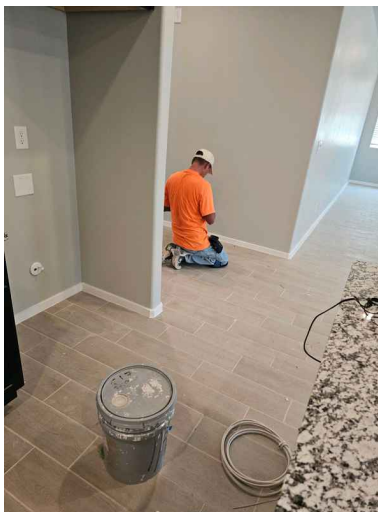
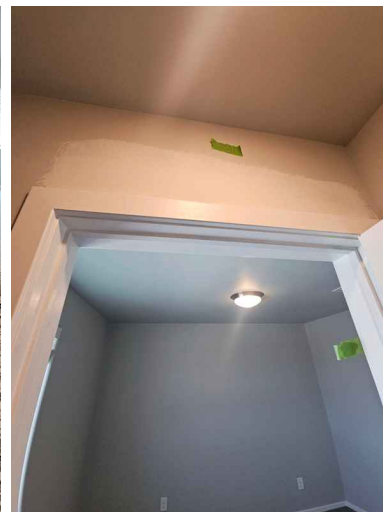
Multiple

## 9: Drywall Painting and Repair In Progress

Drywall finishing work, including painting and repairs, is currently incomplete at the property. This indicates the interior wall surfaces have not yet reached final condition and may require additional work to achieve finished quality standards.

Recommendation: Contact your builder.

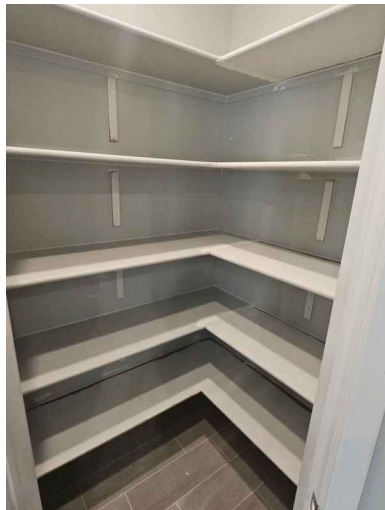
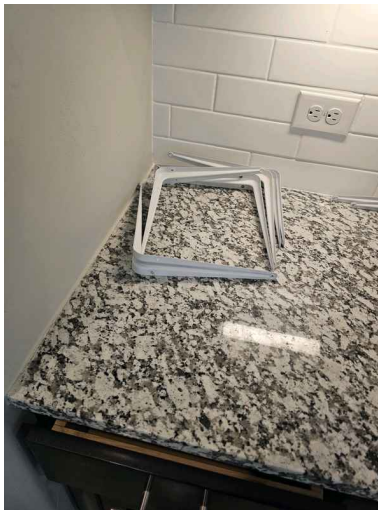
Pantry shelving was observed without finished surfaces during the inspection. The shelves should be completed with appropriate finishing materials to provide a polished appearance and protect the underlying structure from dust and debris accumulation. Contact the builder or a carpentry contractor to complete the finishing work.

Recommendation: Contact your builder.

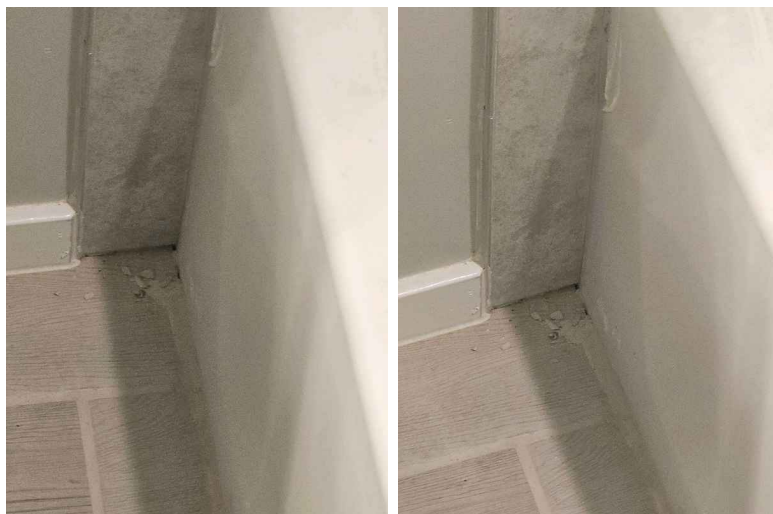
There were grout deficiencies present in the referenced area(s) which may include loose, damaged, or missing areas of grout. Evaluation and repairs to the grout and/or tile as needed is recommended by a flooring contractor.

Recommendation: Contact your builder.

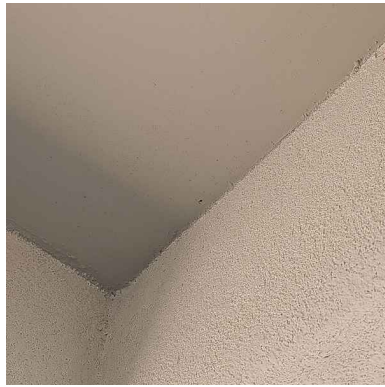
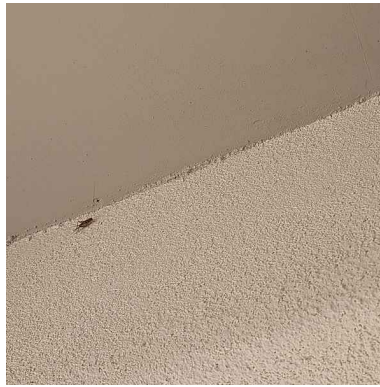
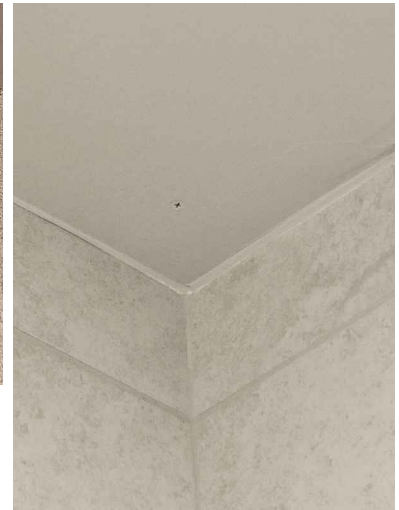
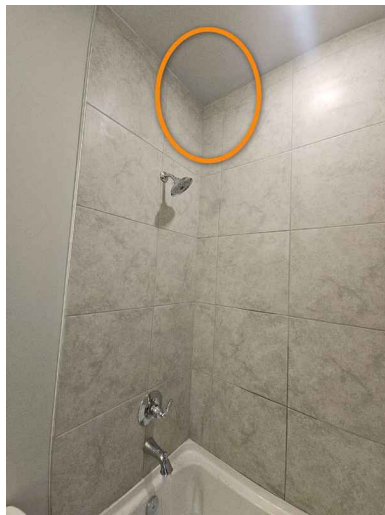
Drywall screws are visible on the ceiling surface. This indicates improper finishing work where screws were not adequately countersunk or covered with joint compound. Visible fasteners can detract from the ceiling's appearance and may indicate incomplete drywall finishing. A drywall contractor should inspect and properly finish these areas by countersinking screws and applying joint compound to create a smooth, professional surface.

Recommendation: Contact your builder.

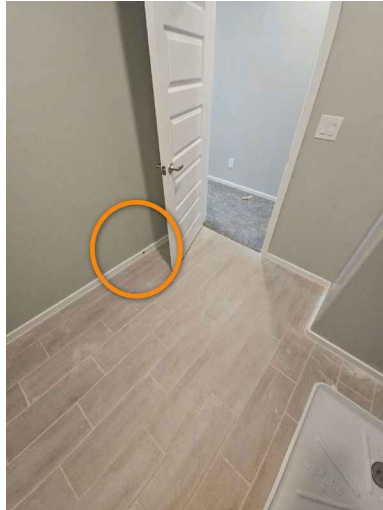
A door stop was not present. Door stops are recommended for any doors that may damage walls or other items during their operation.

Recommendation: Contact your builder.

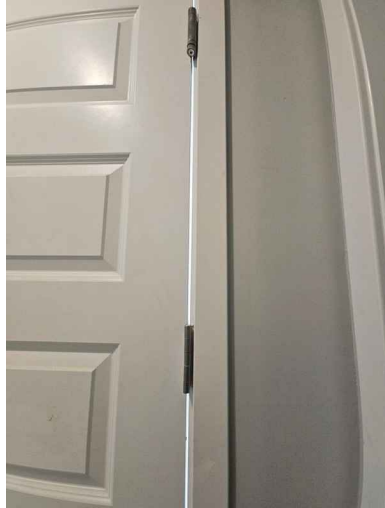
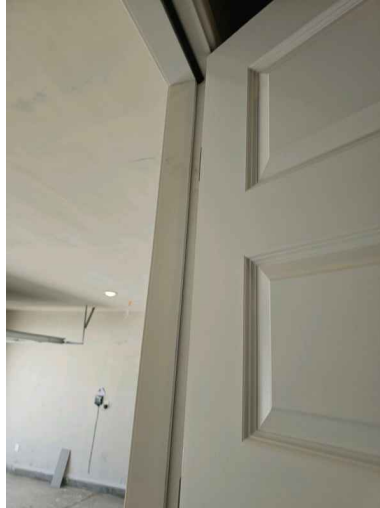
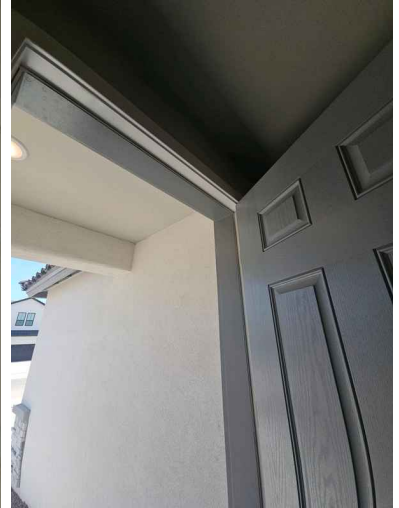
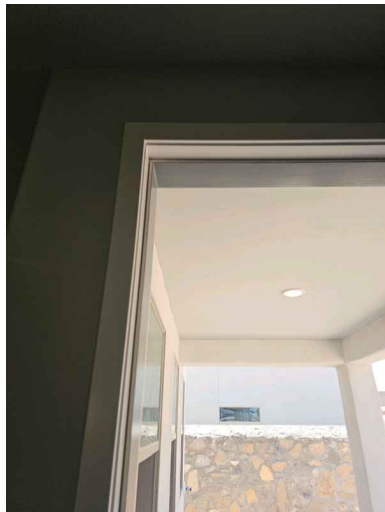
Weatherstripping was observed to be missing from one or more doors. Weatherstripping seals the gaps between door frames and doors to prevent air and moisture infiltration. Missing weatherstripping can allow drafts, water intrusion, and increased energy loss, compromising comfort and potentially leading to water damage or mold growth over time.

Recommendation: Contact your builder.

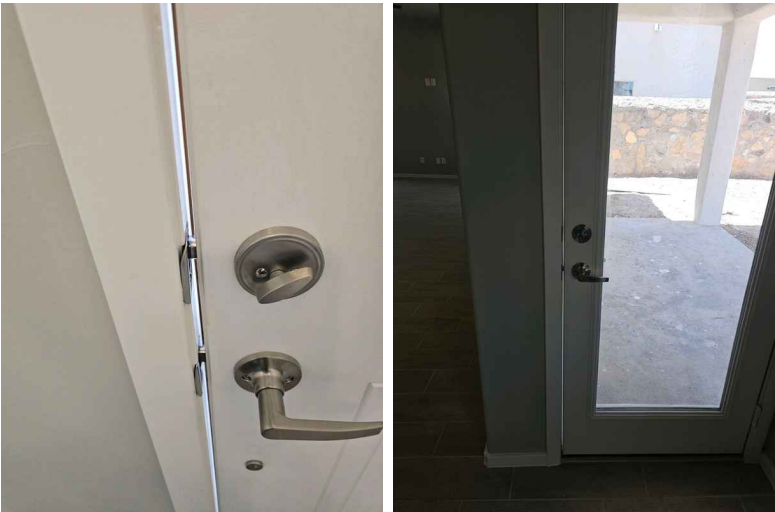
The deadbolt on the referenced door was difficult to engage. Adjustments or repairs needed to achieve smooth operation of the deadbolt.

Recommendation: Contact your builder.

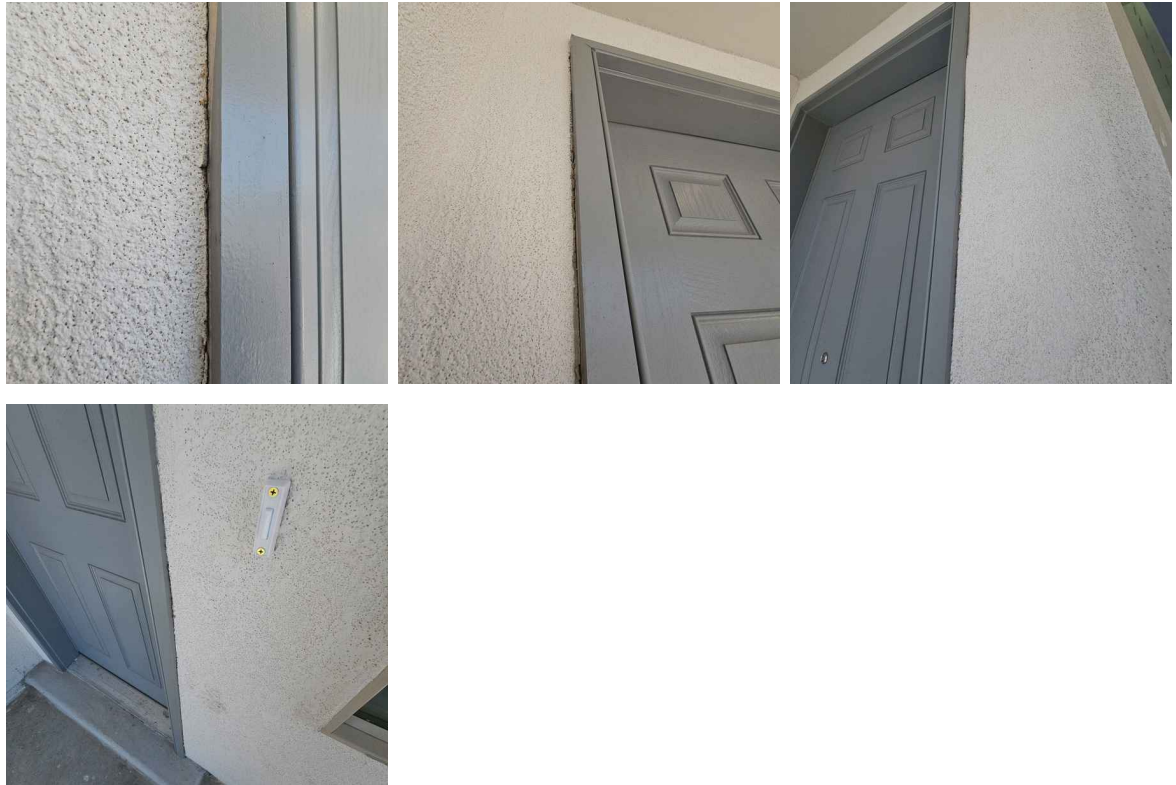
Sealant is missing at the exterior door trim, leaving gaps between the door frame and surrounding wall material. This allows water infiltration during rain, potentially causing damage to the frame, wall structure, and interior surfaces. The trim should be properly sealed with exterior-grade caulk to prevent moisture entry and protect the door assembly.

Recommendation: Contact your builder.

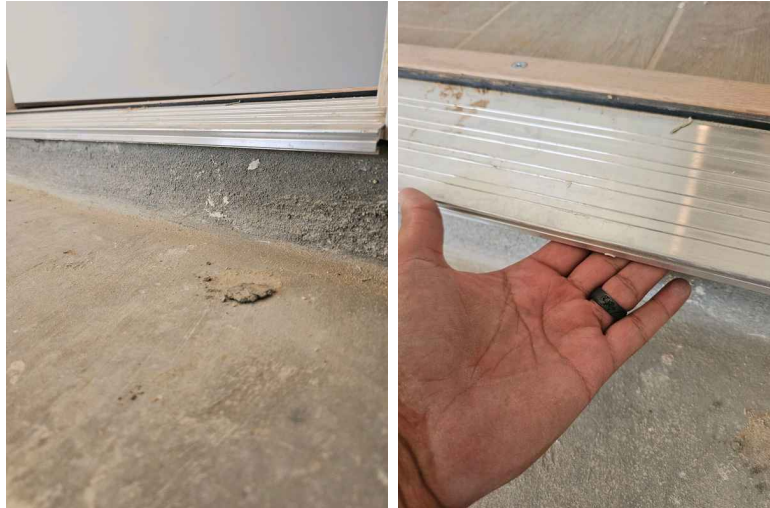
The door threshold at the garage entry overhangs the foundation, creating a trip hazard for anyone entering or exiting the garage. This condition was observed during the structural systems inspection. Occupants could catch their foot on the overhang edge when walking through the doorway, potentially causing a fall. A carpentry contractor should evaluate the threshold installation and either adjust or replace it to eliminate the hazard.

Recommendation: Contact your builder.

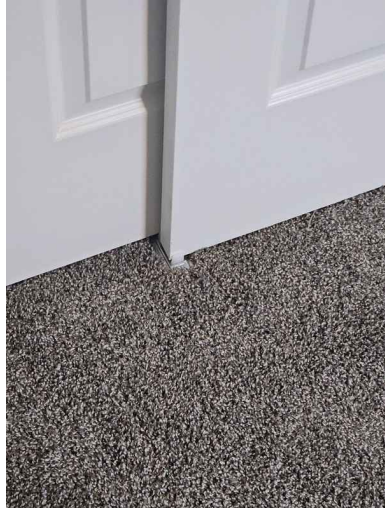
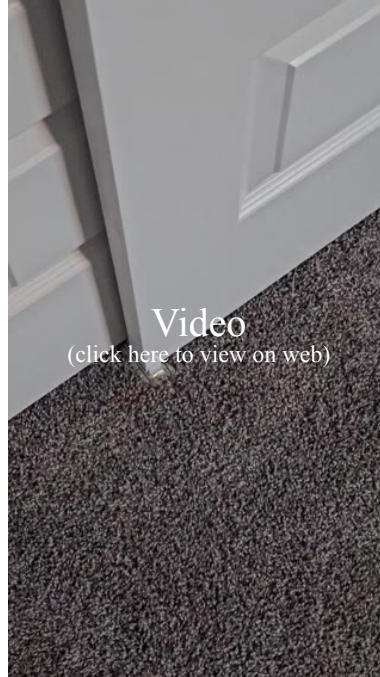
The bottom track of the door is not properly secured, with screws fastened into carpet padding rather than the structural floor beneath. This compromises the track's stability and alignment. The door should be rehung with the track properly fastened to the solid floor using appropriate fasteners. A handyman or carpenter can reset the track and secure it correctly to ensure smooth operation and proper closure.

Recommendation: Contact your builder.

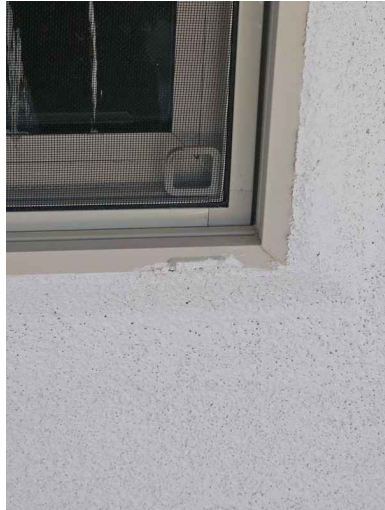
There were windows present where the weep holes have been covered over with flashing, sealant or stucco. This can allow for water to remain in the window frame possibly creating damage. Repairs are recommended by a window contractor to expose the weep holes.

Recommendation: Contact your builder.

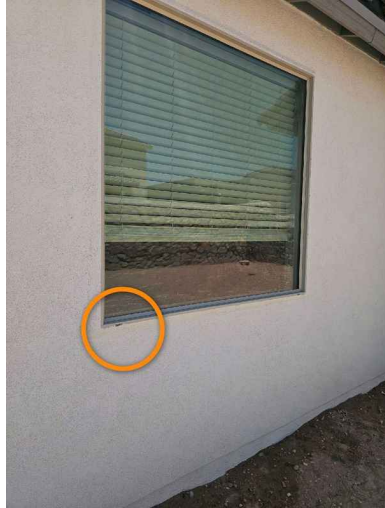
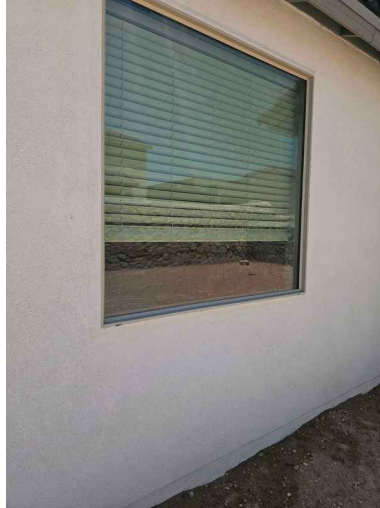
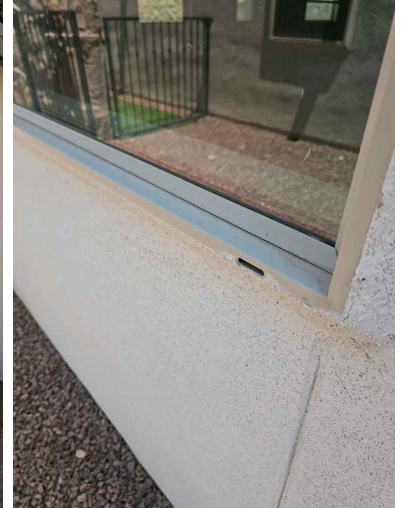
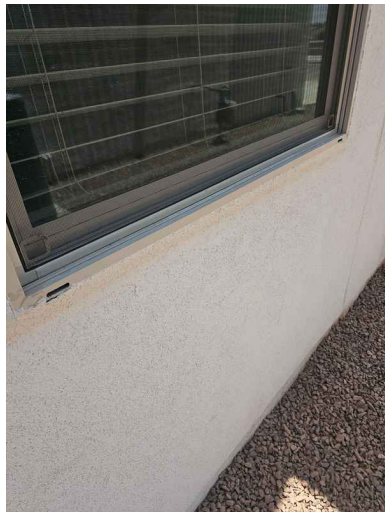
**2: Windows: Weep Hole Covers Missing/Damaged**

Missing/damaged weep hole covers observed at referenced area(s) in need of repair or replacement.

Recommendation: Contact your builder.

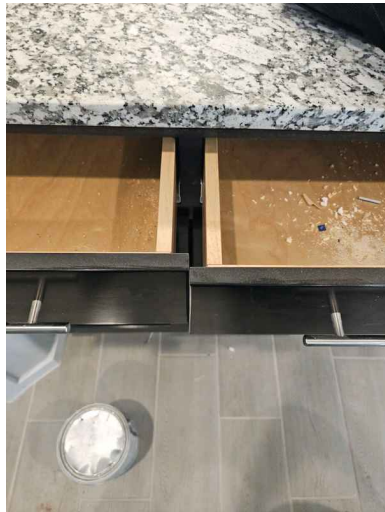
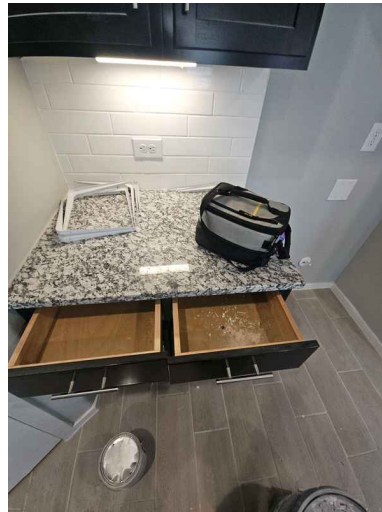
Drawers are hitting each other during operation, indicating a spacing or alignment issue with the cabinetry installation. This suggests the drawers may not be properly spaced or the cabinet frame may be slightly out of square. The drawers should be adjusted or realigned to prevent binding and potential damage to the drawer slides and fronts.

Recommendation: Contact your builder.

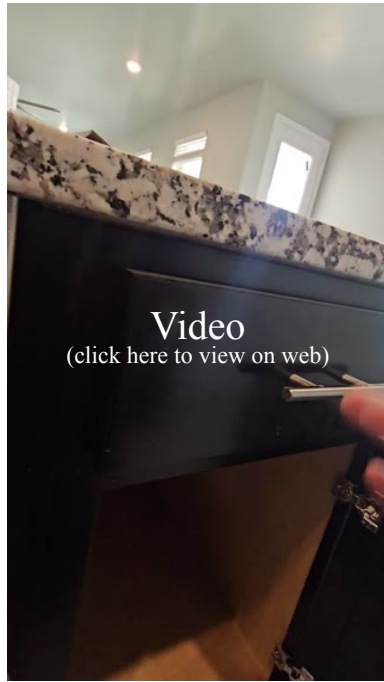
A drawer was observed to stick or bind when opened and closed during inspection. Sticking drawers typically result from misalignment, warping, or debris accumulation in the track. This can make the drawer difficult to operate and may indicate underlying structural settling or moisture-related issues. The drawer track should be inspected for obstructions, cleaned thoroughly, and realigned if necessary; lubrication with a dry silicone spray may also help restore smooth operation.

Recommendation: Contact your builder.

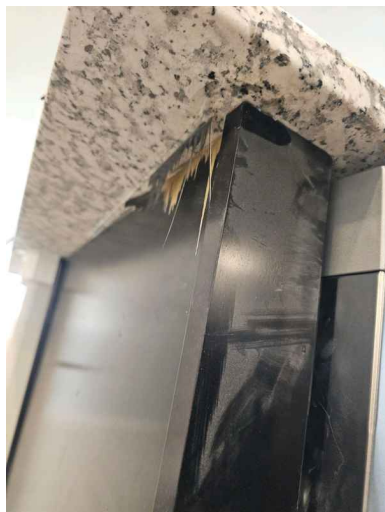
### 3: Cabinet Damage at Counter Top

Damage to cabinetry at the countertop was observed during inspection. Cabinet damage can affect functionality, appearance, and water resistance at the countertop interface. A cabinet contractor should evaluate the extent of damage and recommend appropriate repairs or replacement.

Recommendation: Contact your builder.

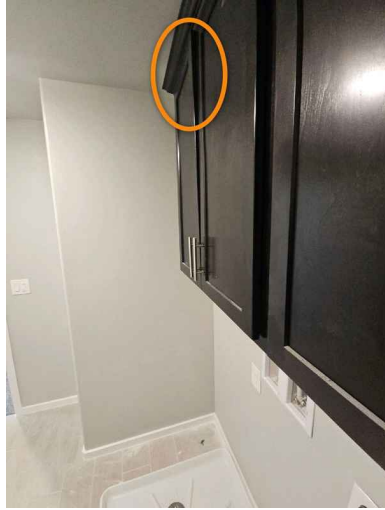
A cabinet door exhibits warping, which is a permanent bending or twisting of the door panel. Warped doors may not close properly, leaving gaps that expose cabinet contents and can affect the appearance and functionality of cabinetry. A cabinet contractor should evaluate the extent of the warping to determine whether adjustment, replacement, or refinishing is appropriate.

Recommendation: Contact your builder.

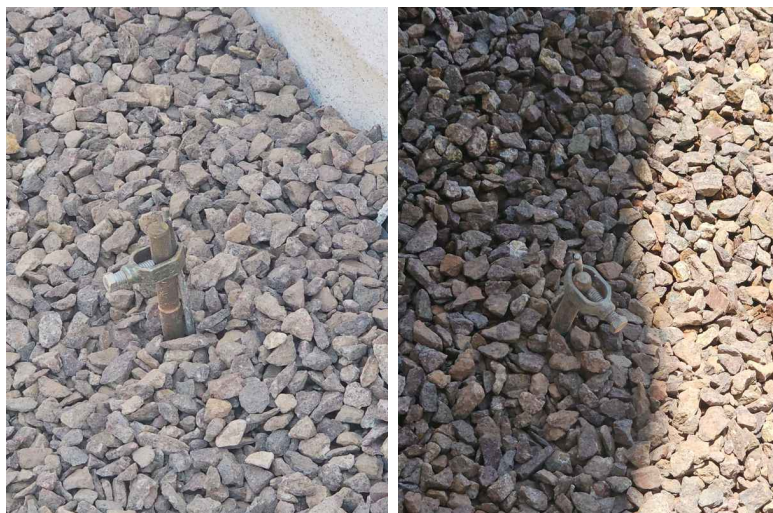
The ground rod was not driven into the soil. Typically these rods are exactly eight feet in length, and the rod needs to be in contact with the soil for a full eight feet to provide proper grounding protection. Driving the rod into the earth flush with the soil is recommended to be conducted by a licensed electrician.

Recommendation: Contact your builder.

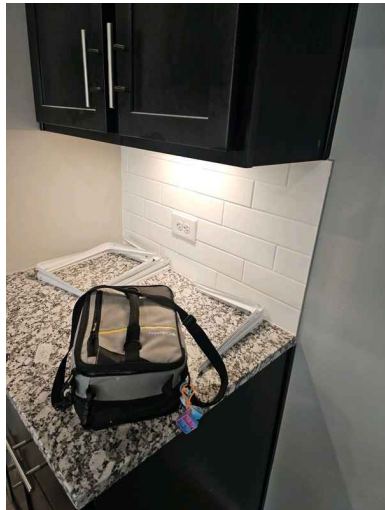
## 1: Receptacle(s): Loose at Wall

There were receptacle(s) present that were loose at the wall. Proper securement of any loose receptacles is recommended to be conducted by a licensed electrician.

Recommendation: Contact your builder.

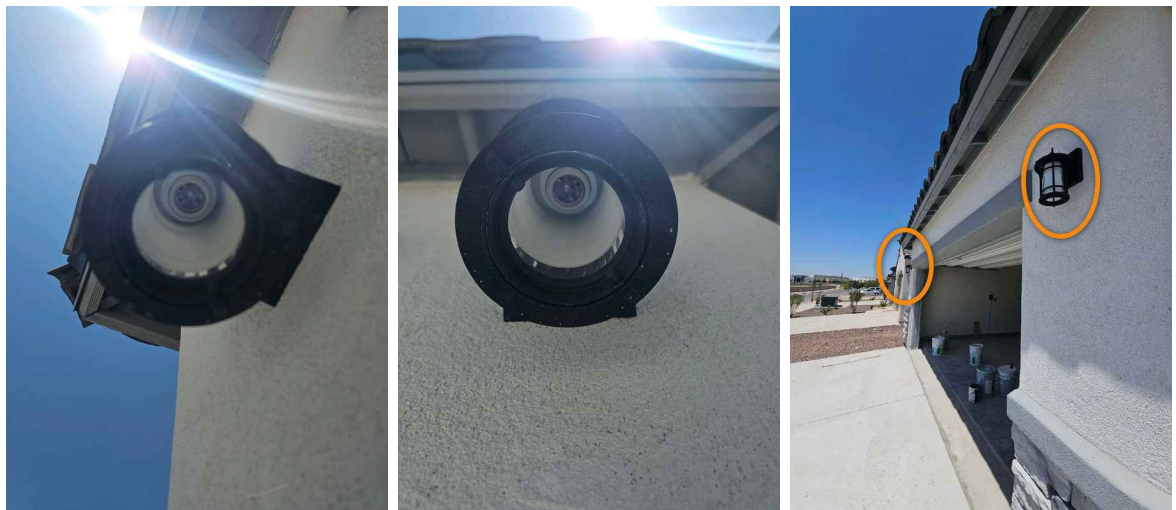
## 2: Light Bulb(s): Not Installed

The referenced area(s) did not have a light bulb installed, and therefore the fixture(s) were not able to be tested for functionality. I recommend confirming proper operation prior to closing.

Recommendation: Contact your builder.

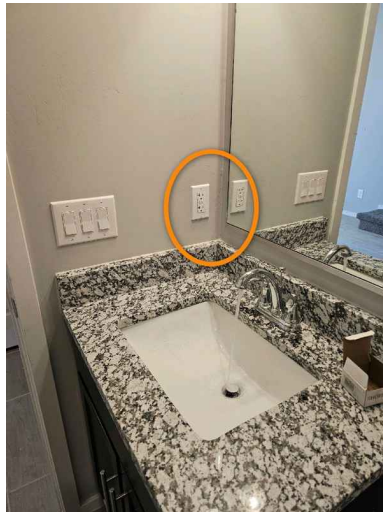
### 3: GFCI: Found Tripped/Not Resetting

The referenced GFCI receptacle(s) was found in the "tripped" position, and would not reset, rendering the receptacle(s) non-functional. Replacement of the affected receptacle(s) is recommended to be conducted by a licensed electrician.

Recommendation: Contact your builder.

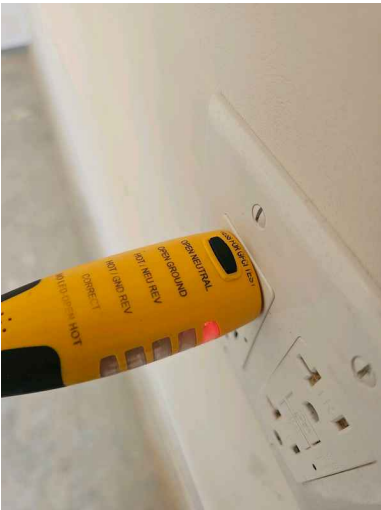
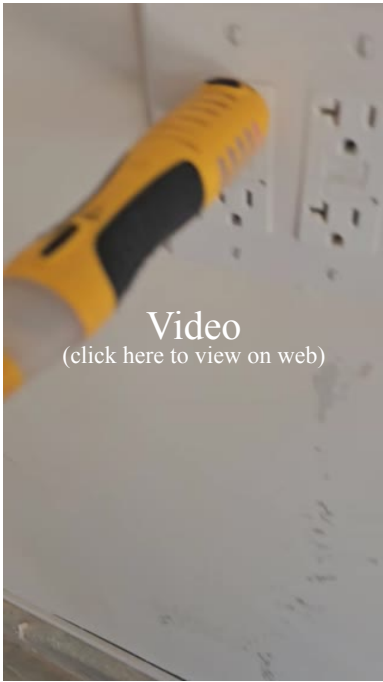
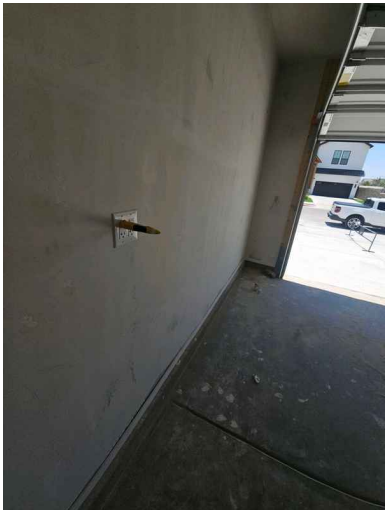
An open neutral condition exists in the electrical system, meaning the neutral conductor is disconnected or broken at some point in the circuit. This was discovered during inspection of the branch circuits and connected devices. An open neutral creates a serious safety hazard, as it can cause voltage imbalances, damage to appliances, and potential shock or fire risks. A qualified electrical contractor must locate and repair the break in the neutral conductor immediately.

Recommendation: Contact your builder.

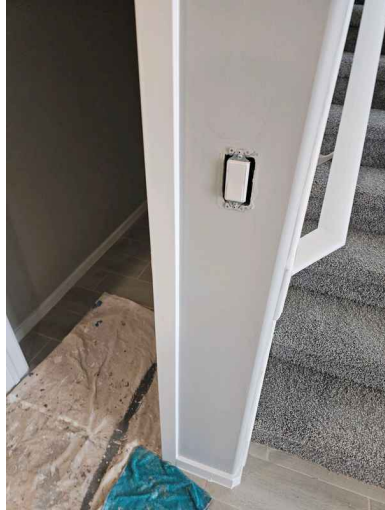
**5: Missing Light Switch Cover**

A light switch cover plate was not installed on an electrical switch outlet. This leaves the switch opening exposed, which can allow dust and debris to enter the electrical box and creates a potential safety concern. Install a standard cover plate over the switch to protect the electrical components and ensure proper safety.

Recommendation: Contact your builder.

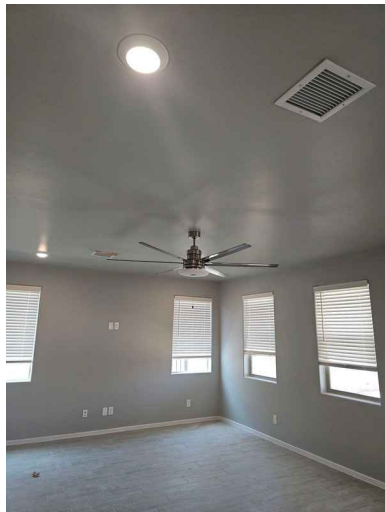
**6: Ceiling Fan and Light Not Functional**

The ceiling fan and light fixture are not operating. During testing of the branch circuit, neither the fan motor nor the light responded to switch activation. This indicates a problem with either the fixture wiring, the switch connection, or the fixture itself, and should be evaluated by an electrical contractor to determine the cause and restore proper operation.

Recommendation: Contact your builder.

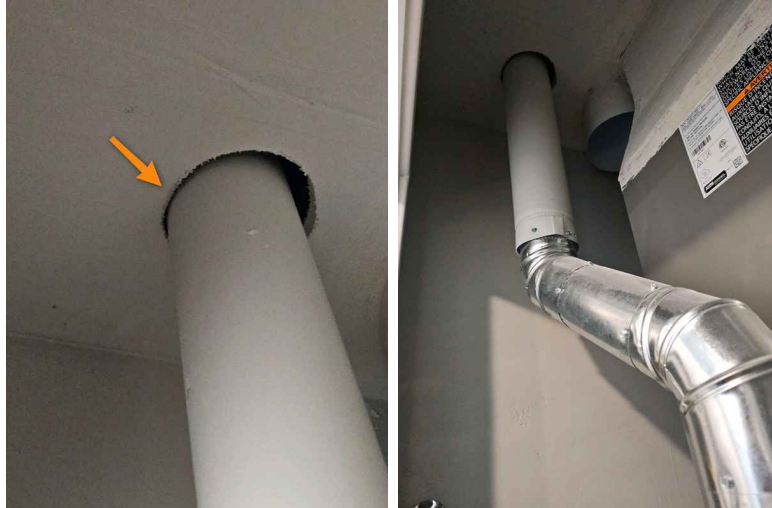
The heating equipment flue pipe is positioned too close to combustible materials. This creates a fire hazard, as excessive heat from the flue can ignite nearby wood framing, insulation, or other flammable materials. A qualified HVAC professional should evaluate the flue clearance and relocate or shield it to meet safe distance requirements.

Recommendation: Contact your builder.

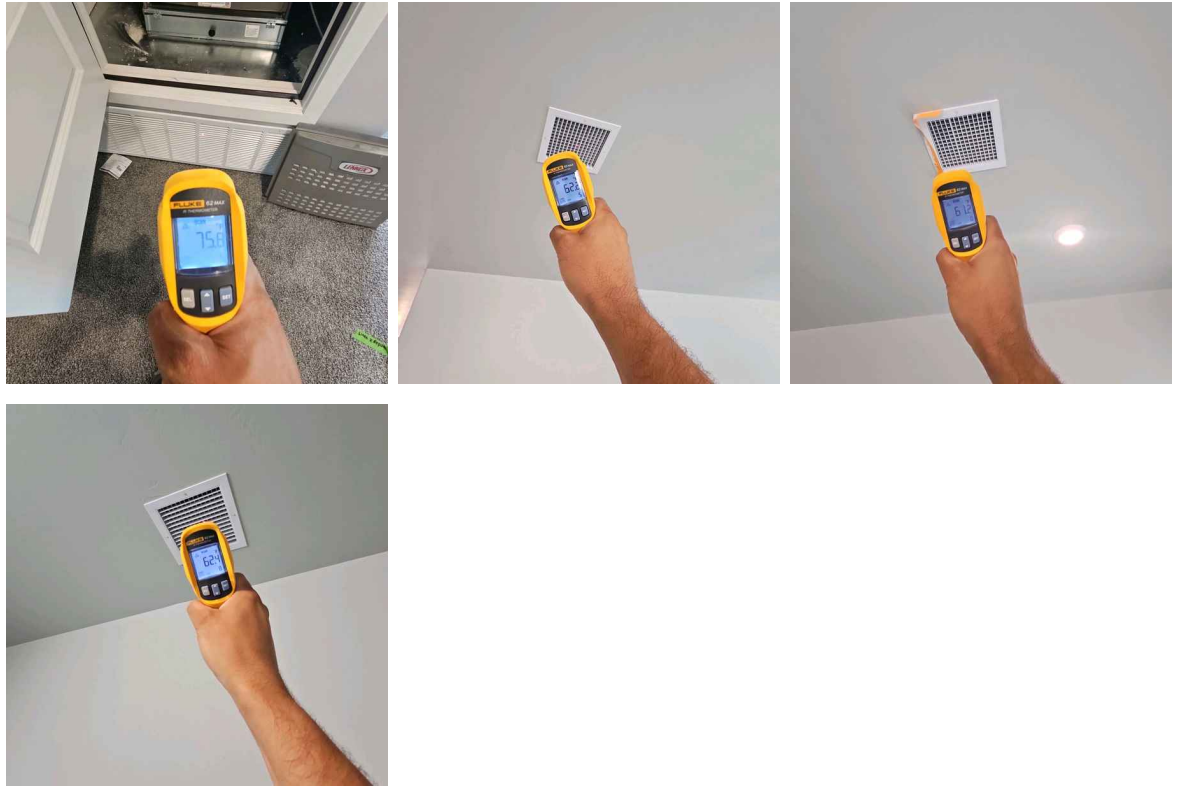
The HVAC system temperature was measured at the return plenum and supply register. The HVAC unit returned a value outside the normal operating temperature differential of 15- 22 Degrees. An evaluation is recommended to be performed by an HVAC contractor with repairs made as needed for proper operation.

Recommendation: Contact a qualified HVAC professional.

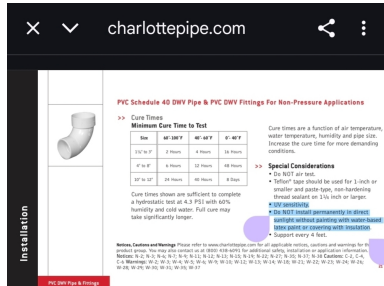
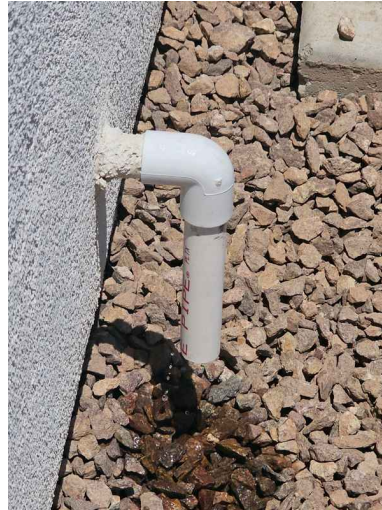
The exterior PVC condensate drain line was observed to be unpainted. Exposure to sunlight can cause deterioration over time. Recommend builder evaluate and paint the line to protect it from UV damage.

Recommendation: Contact your builder.

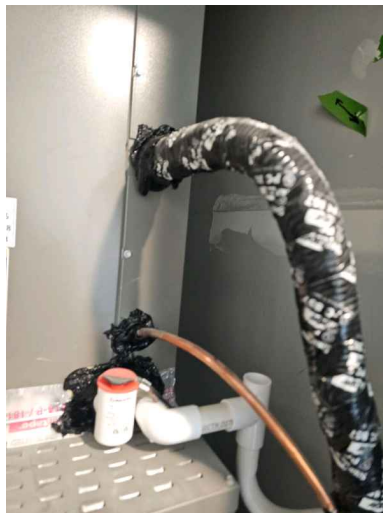
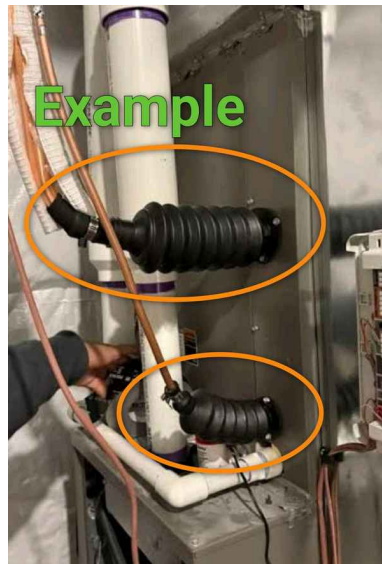
## 3: A2L Lineset Joint Sleeves Not Installed

Line set Joint Sleeves were not installed at the A2L refrigerant line penetrations at the time of inspection. Missing Sleeves may allow air leakage, moisture intrusion, and energy loss. In systems using A2L mildly flammable refrigerants, unsealed penetrations may also allow unintended migration or escape of refrigerant into living spaces.

Recommendation: Contact your builder.

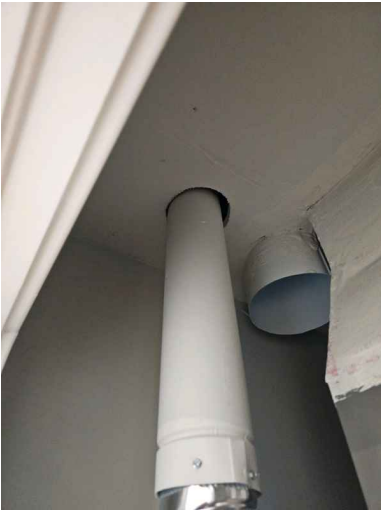
A fire stop collar was not installed where the duct system penetrates a fire-rated wall or floor assembly. Fire stop collars are required to maintain the fire-rating of the penetration and prevent fire and smoke from spreading through the duct opening. Installation of an appropriate fire stop collar is necessary to restore the fire-rated integrity of the wall or floor assembly.

Recommendation: Contact your builder.

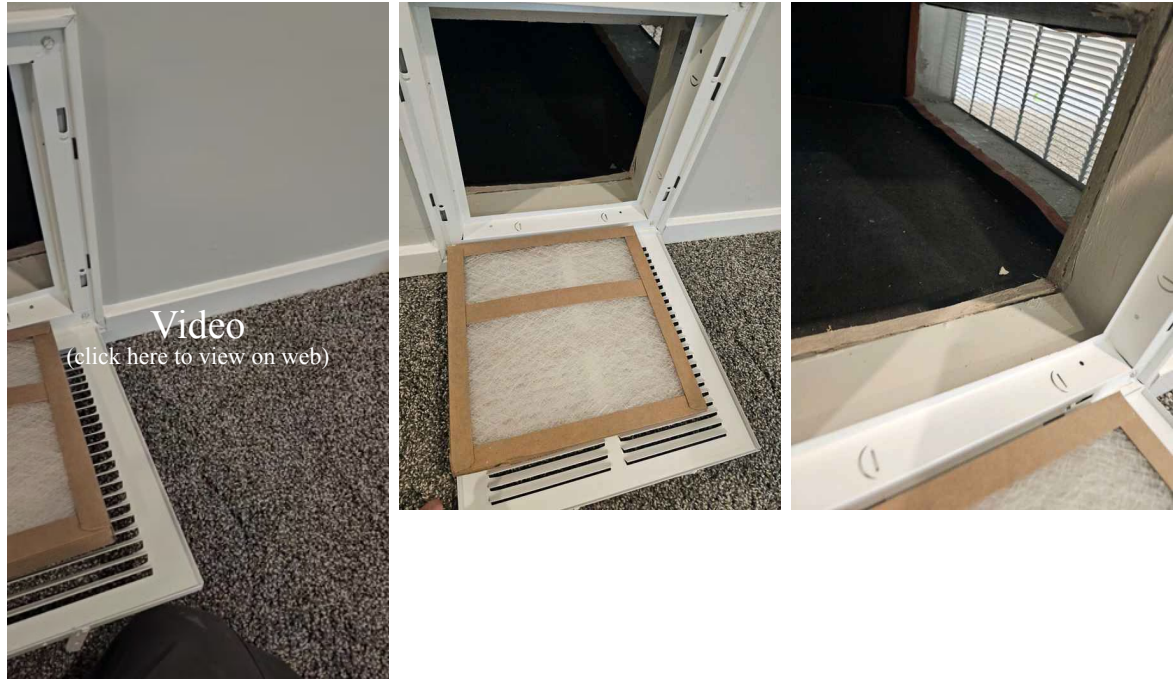
An additional HVAC filter was found installed in the duct system beyond the standard filter location. While extra filtration can improve air quality, multiple filters in series may restrict airflow and reduce system efficiency, potentially causing the heating and cooling system to work harder than necessary. Have an HVAC professional evaluate the filter configuration to ensure proper airflow and system operation.

Recommendation: Contact your builder.

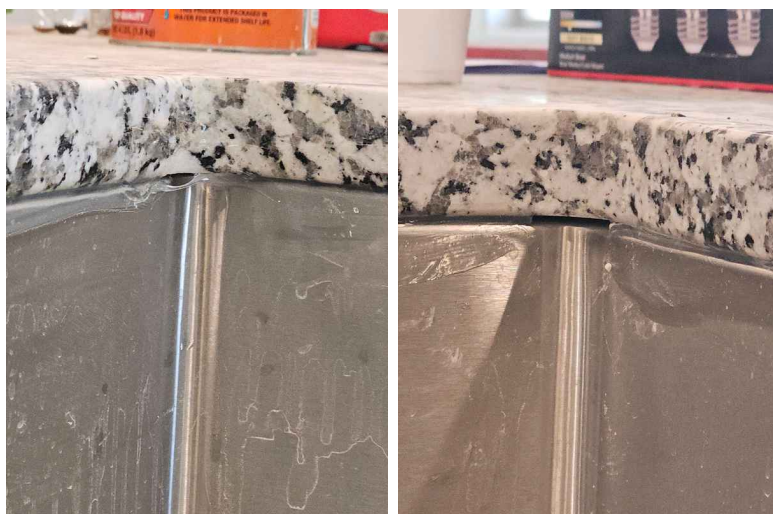
Gaps were present where the sink transitions to the countertop. I recommend sealing around the sink as needed to prevent water / moisture infiltration.

Recommendation: Contact your builder.
