## TEXAS NEW CONSTRUCTION

1234 Main Street  
Socorro TX 79927

# PROPERTY INSPECTION REPORT FORM

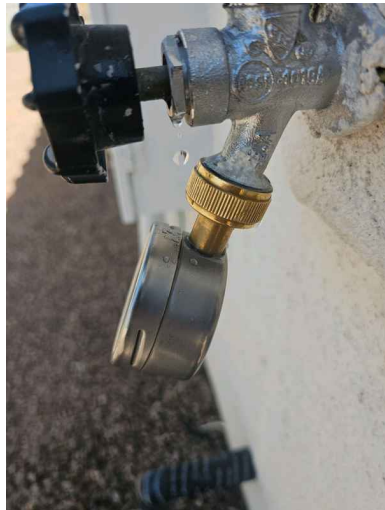
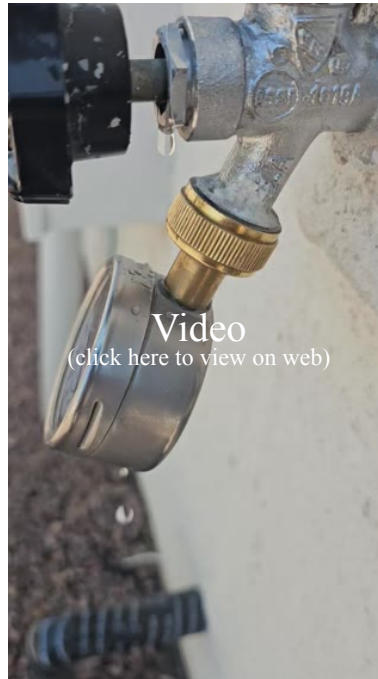
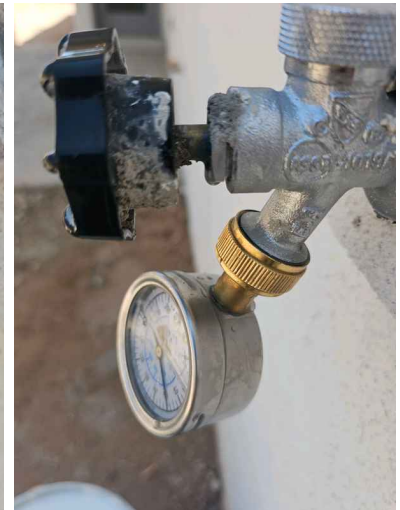
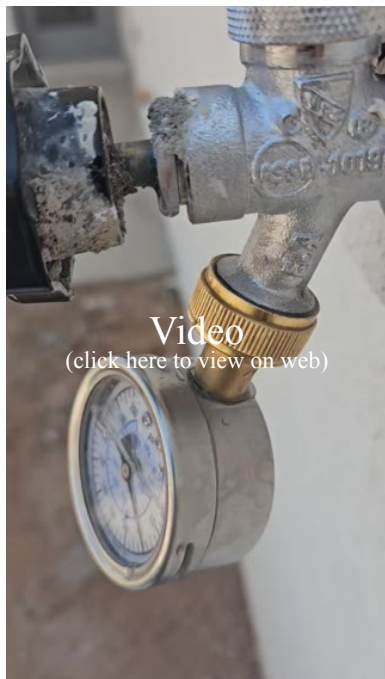
## 2: Spigot(s): Leak From Valve Stem

The referenced spigot was leaking from the valve stem area while under pressure. Repairs are recommended to be conducted as needed by a licensed plumber or other qualified person for proper operation.

Recommendation: Contact your builder.

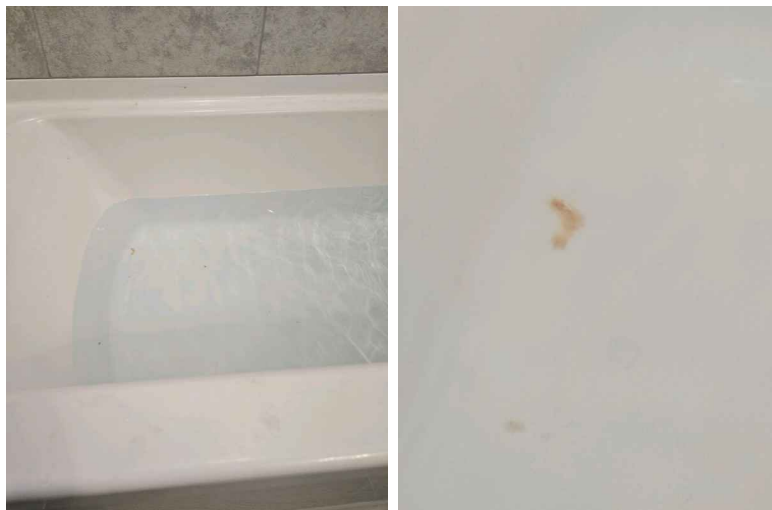
### 3: Bathtub Staining

Staining observed on the bathtub surface during inspection. Tub stains can result from mineral deposits, rust, mold, or soap residue accumulation. While primarily a cosmetic concern, persistent staining may indicate underlying plumbing issues such as mineral-rich water or rust from corroded fixtures that warrant investigation.

Recommendation: Contact your builder.

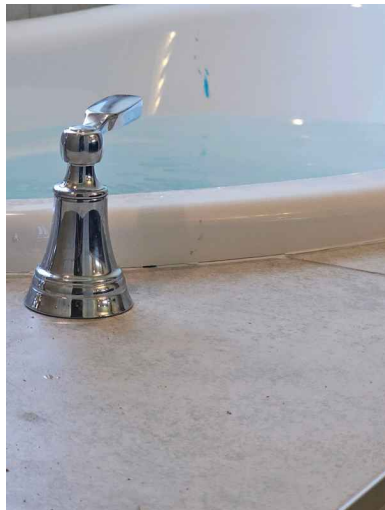
Gaps were observed in the caulking or sealant around the bathtub perimeter during inspection. Water can penetrate these gaps and reach the substrate behind the tub, potentially causing water damage, mold growth, and structural deterioration. The sealant should be removed and replaced with a high-quality, waterproof caulk suitable for wet areas.

Recommendation: Contact your builder.

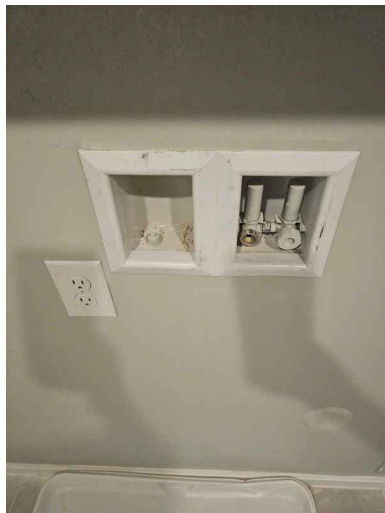
*Washing Machine Drain Knockout :*

The Washing Machine Drain in the laundry room still has the knockout attached.

This is done for good reason and to not allow debris to fall in during the construction phase and to not allow for sewer gas to enter the home when the trap dry's out. If you are bringing your own Washing Machine follow up with the builder to remove this for you prior to moving in and verifying the drain for possible leaks.

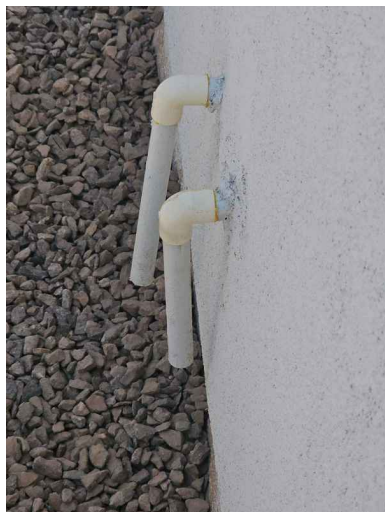
CPVC drain pipes observed during inspection lack UV protection. Unprotected CPVC exposed to direct sunlight can degrade over time, becoming brittle and prone to cracking. The pipes should be shielded from UV exposure using appropriate protective measures or relocation away from direct sunlight.

Recommendation: Contact your builder.

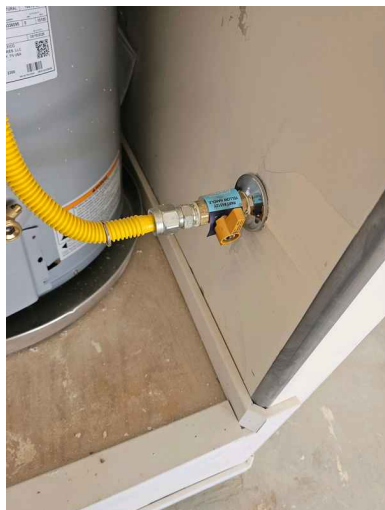
*Gas Off:*

The gas was off at the home at the time of inspection, and the unit was not able to be tested for functionality. I recommend confirming proper operation prior to closing.

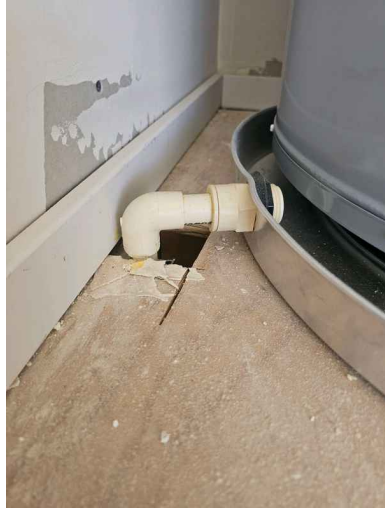
A gap was observed between the water heater and the surrounding deck area during inspection. This opening can allow water, debris, and pests to accumulate beneath the unit, potentially causing corrosion, structural damage, and pest entry. The gap should be sealed or the deck structure should be adjusted to ensure proper clearance and drainage while preventing debris accumulation.

Recommendation: Contact your builder.

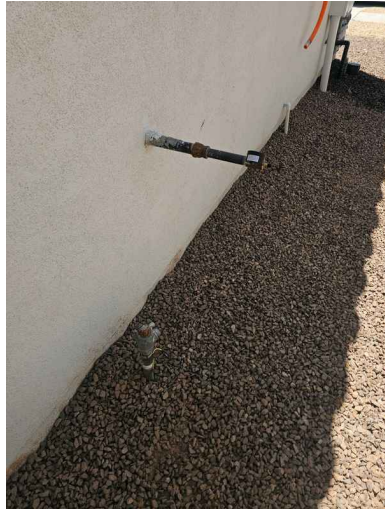
*Gas: Not Installed :*

The gas meter was not installed at the time of inspection.

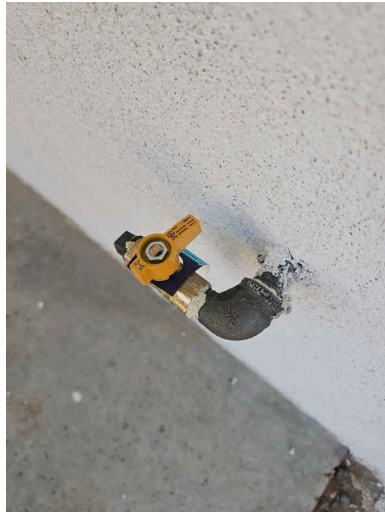
Patio

**1: Black Steel Lines: Unprotected**

Black steel gas lines were observed unprotected on the exterior of the property. Exposure to moisture and other elements can lead to rust and corrosion, potentially compromising the integrity of the gas lines. Recommend builder paint or wrap the gas lines with appropriate protective materials designed for exterior use to prevent rust and protect them from environmental damage.

Recommendation: Contact your builder.

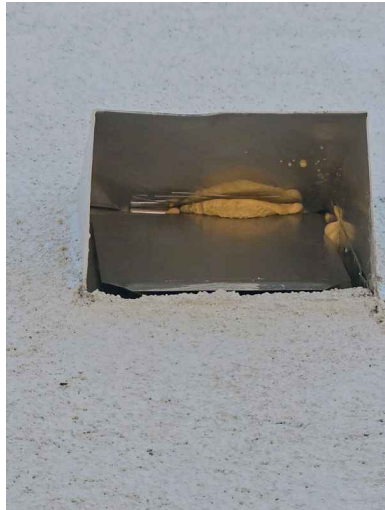
The exhaust vent flap is not opening properly during operation. This restricts airflow and prevents moisture and odors from being effectively vented outside. The damper should be inspected and repaired or replaced to restore proper ventilation function.

Recommendation: Contact your builder.

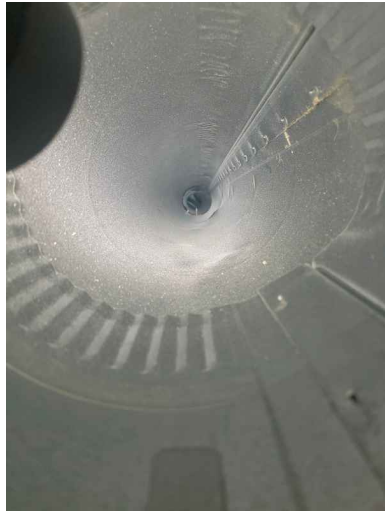
**1: Screw Protruding Into Dryer Vent****Dryer Vent**

A screw is protruding more than 1/8 inch into the dryer exhaust vent. This obstruction can restrict airflow and reduce dryer efficiency, potentially causing lint buildup and creating a fire hazard. A qualified professional should remove or replace the screw and verify proper vent clearance.

Recommendation: Contact your builder.
